Provisional Position Paper 11

**Potentially Deficient Features
of the water system
of the QEUH/RHC**

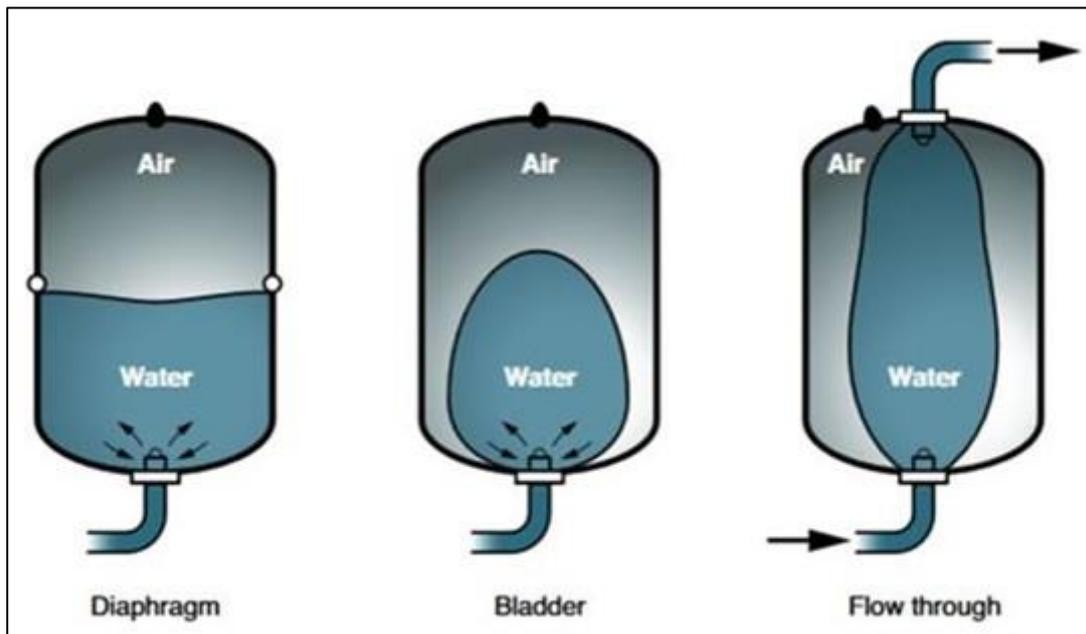
- 13.3. HSE guidance on Legionnaire’s Disease illustrates common designs for expansion vessels, including the directions of water flow, and describes further the risk of certain materials providing a surface location for contamination:

“...In pressurised systems, a means of accommodating water expansion (caused by the water heating) is required. This is often achieved with the use of an expansion vessel. However, these may not fill and empty where the system pressure and temperature remains steady....

- 13.4. These internal bladders are often made of synthetic rubber such as EPDM and may support the growth of microorganisms. Vessels with a ‘flow through’ design should provide less opportunity for water to stagnate and become contaminated (as in the latter design).¹⁹³
- 13.5. DMA Canyon, in their Risk Assessment dated 25 April 2017, raised a concern regarding the design of expansion vessels, indicating that they were not of the ‘flow through’ type recommended in the passages above, and raised the possibility that the vessels had not received servicing:

“The expansion vessels attached to the calorifiers are not of a flow through design as recommended in HSG 274 Part 2 (info Box 2.1) and SHTM 04-01 Part A (Para 8.22) and they are not insulated as recommended in SHTM 04-01 Part A (Para 8.22). Estates advised that there is an intention to alter the pipework and vessels to accommodate flow through vessels in early 2019. Generally water flushed from drain on calorifiers and expansion vessels ran clear either instantly or after only a very short period of time (typically less than 10 seconds). No internal records of inspection for calorifiers were available”¹⁹⁵
