SCOTTISH HOSPITALS INQUIRY

**Bundle of documents for Oral hearings
commencing from 19 August 2024 in
relation to the Queen Elizabeth University
Hospital and the Royal Hospital for
Children, Glasgow**

**Bundle 22 - Core Participant Responses to
PPPs**

Responses to Provisional Position Paper 11 - Water

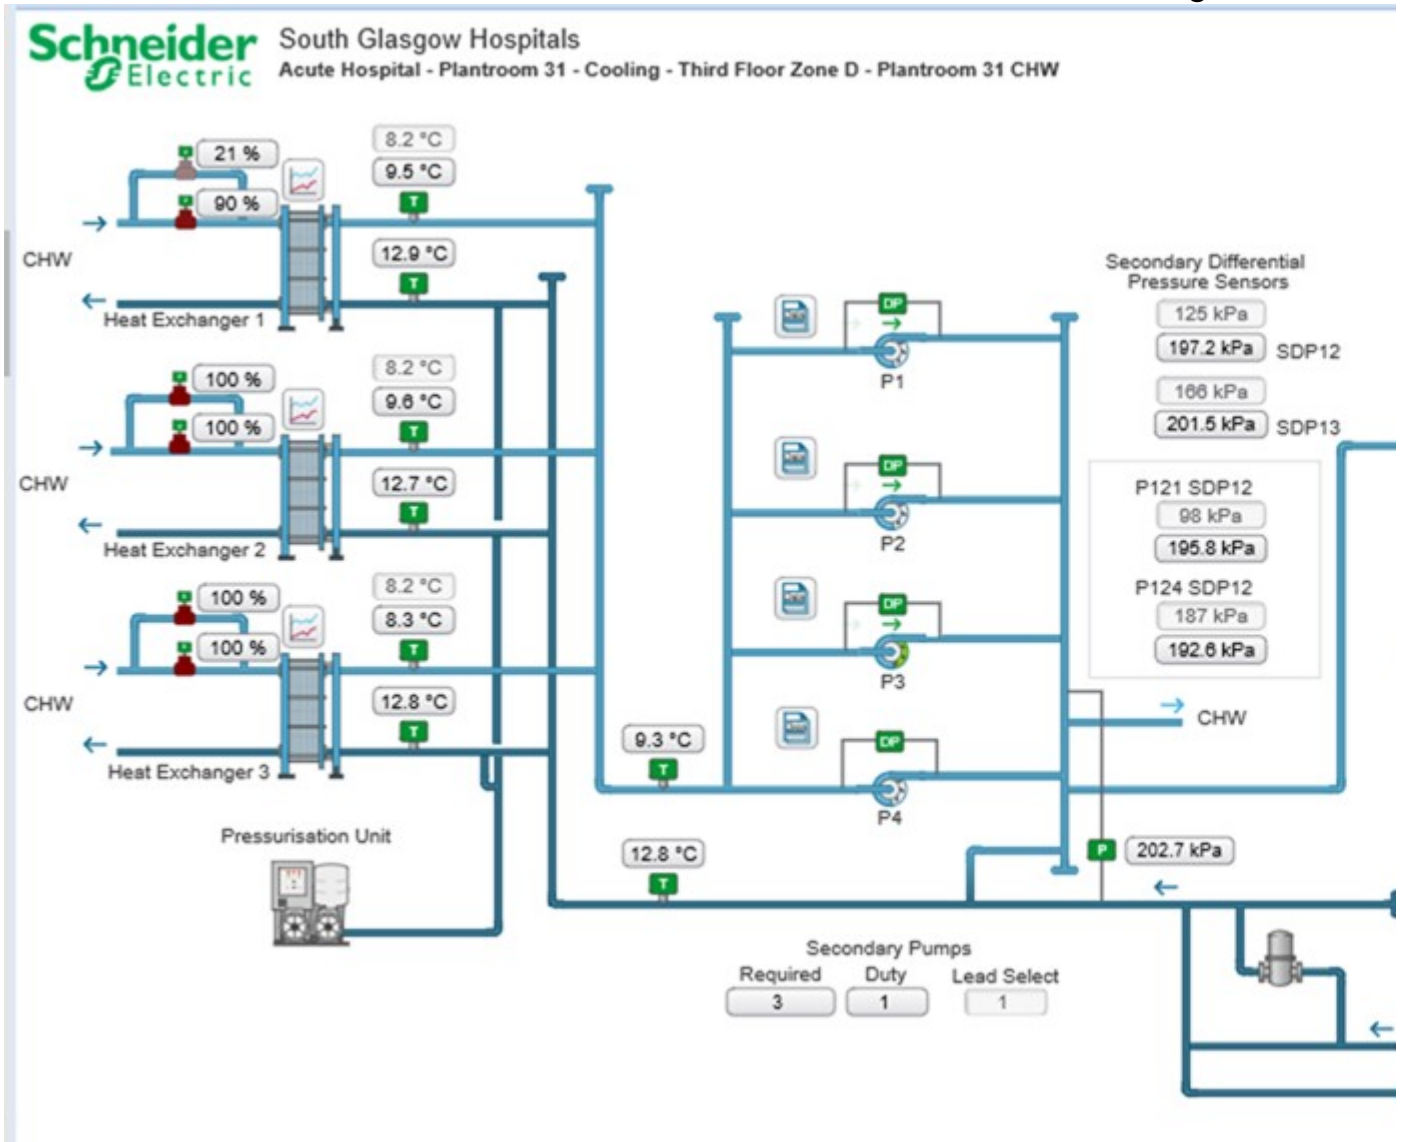
System example :

The idea is to create a 2 degree buffer due to the lag on the system adjustment
Space temperatures will be monitored for significant temperature increase and adjusted accordingly.

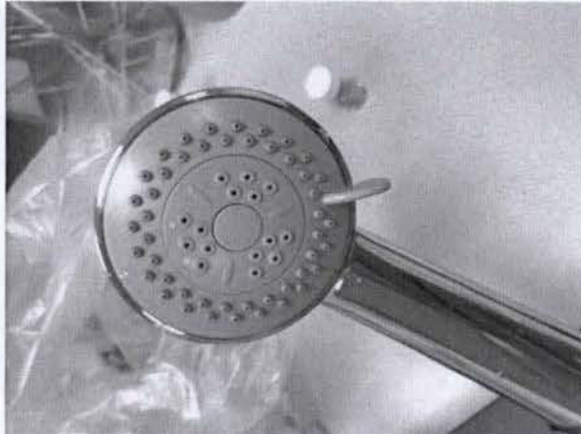
Shower head –

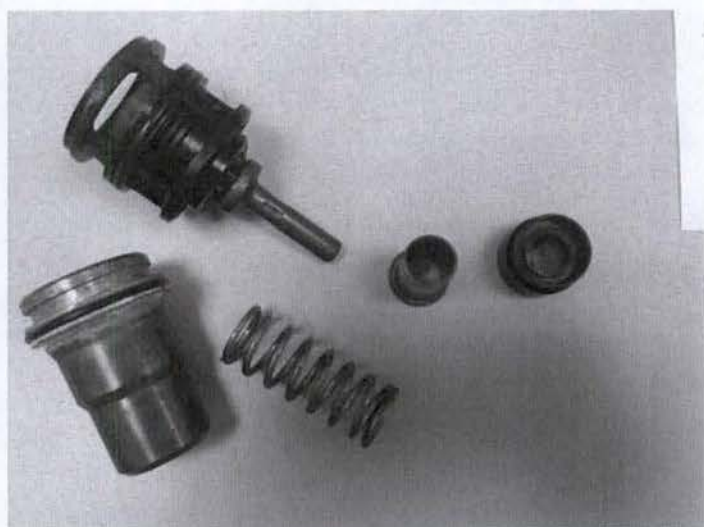
- 1.
2. **TAP TMV**

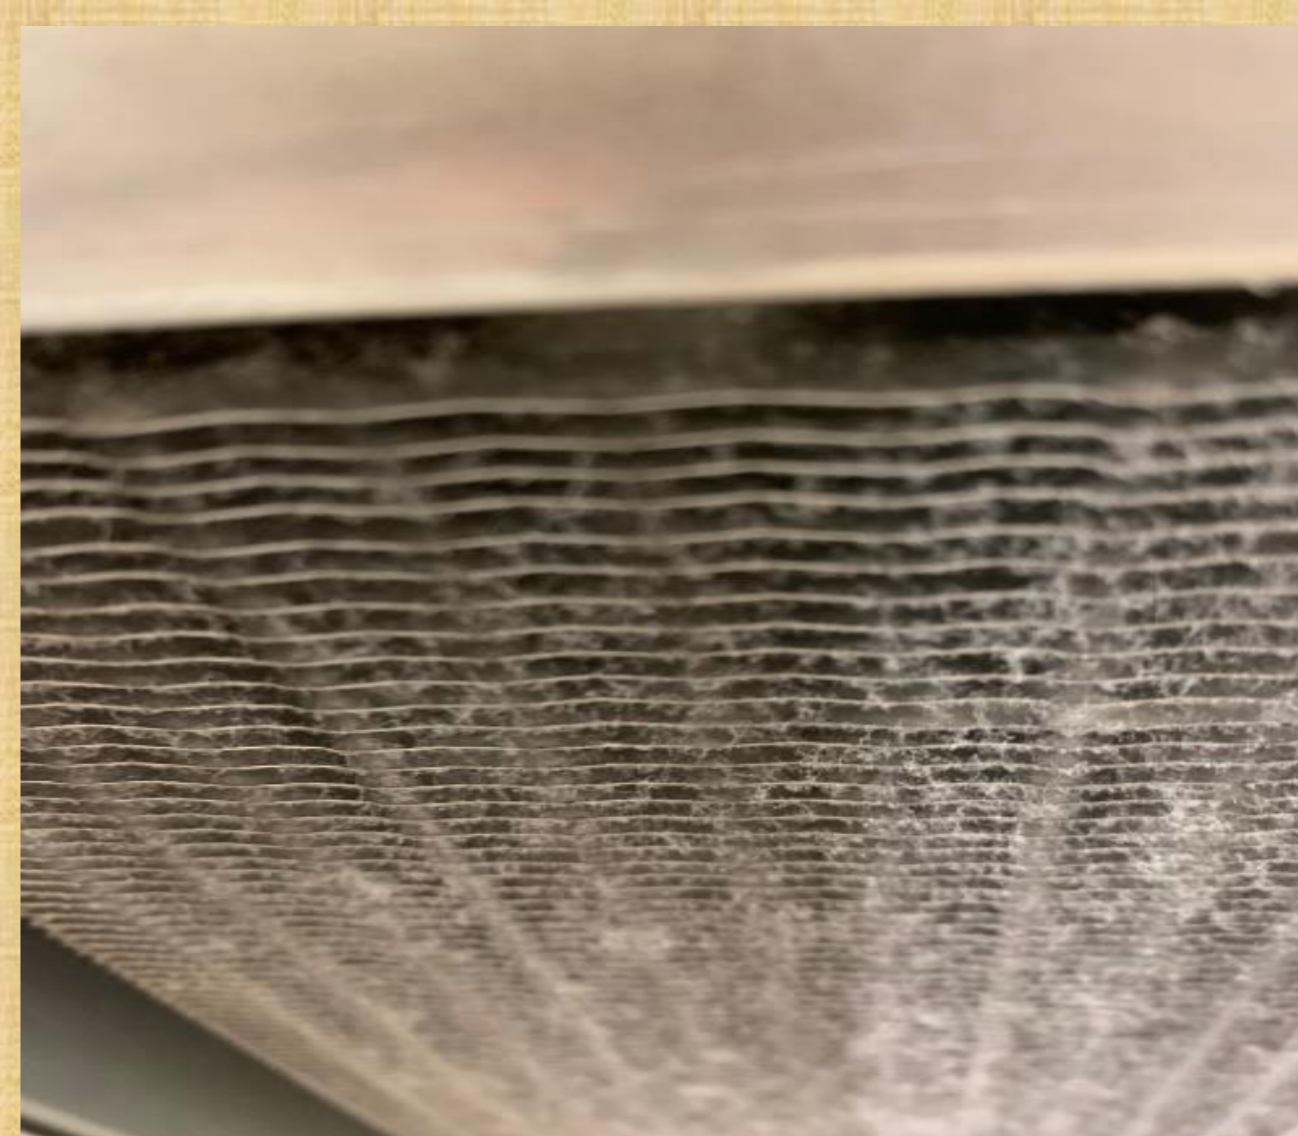
CHILLED BEAM IN BEDROOM CEILING

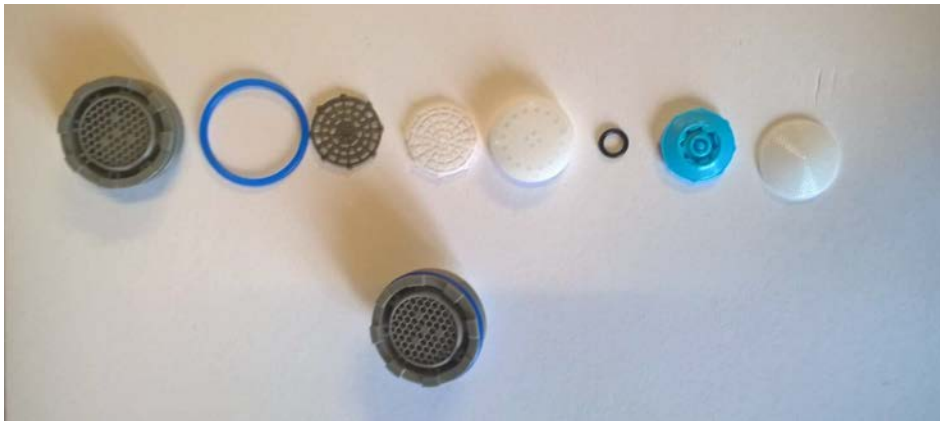
Fully dismantled flow straightener.

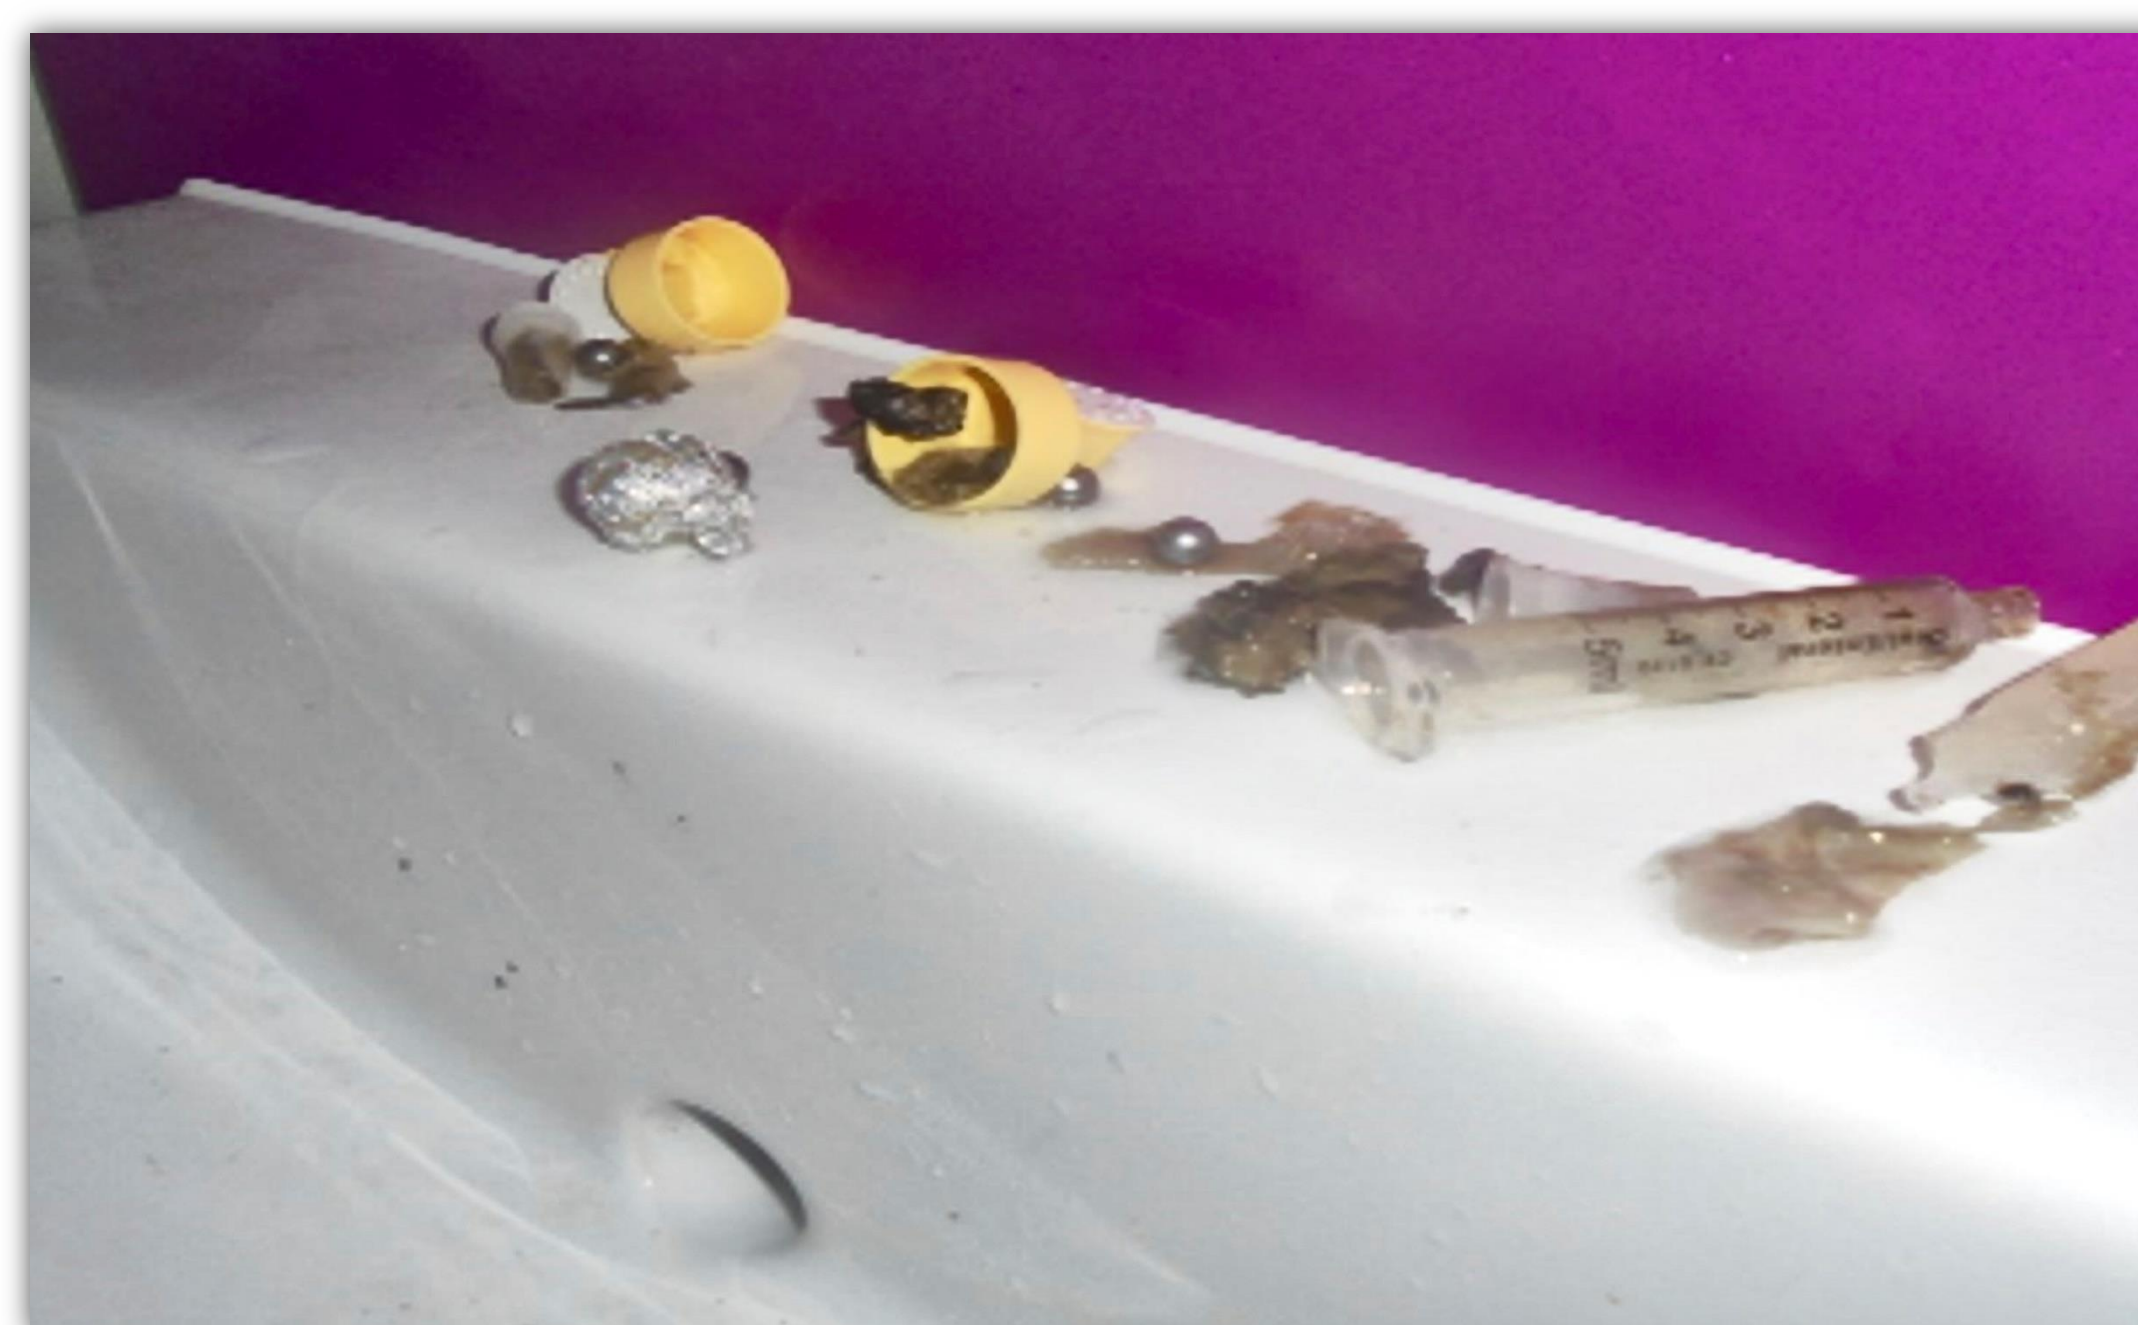
5. ITEMS REMOVED FROM WASTE TRAP OF SINK WITH REAR DRAIN AND NO SIEVE WHICH INCLUDES SYRINGES AND AMPOULES

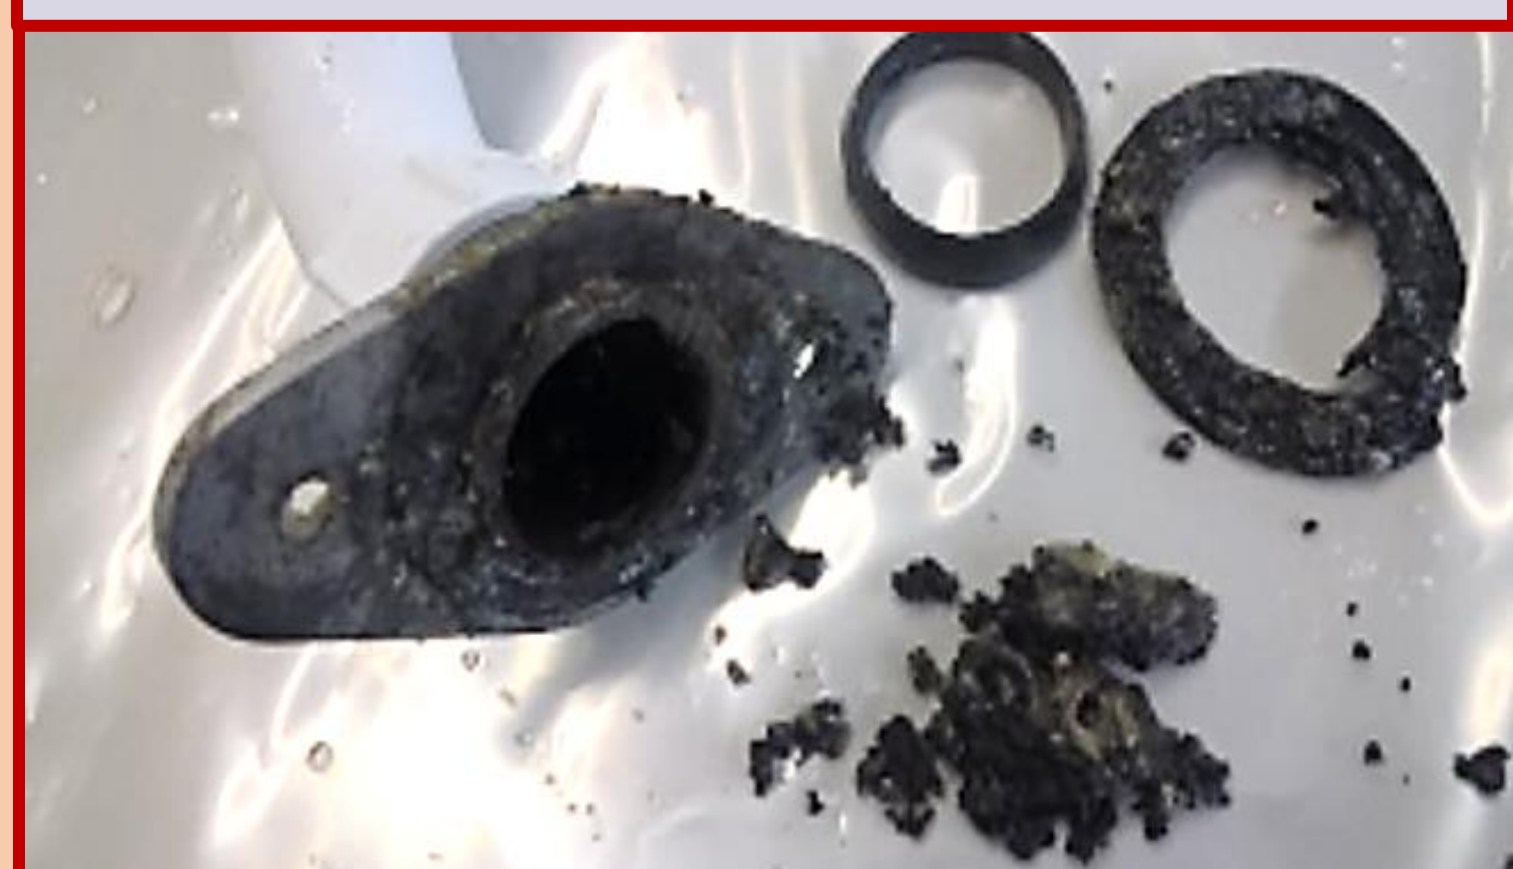
2. CORROSION OF COMPONENTS

Drains were found not to be flush with the back of the sink with a lip present where water was stagnating (see image 1. below). Excess sealant was present in the drains and there was corrosion of an aluminium component (see image 2.). Mature biofilm and high bacterial counts were detected along with evidence of nutrients in drains. These included foodstuffs and urine in sink drains.

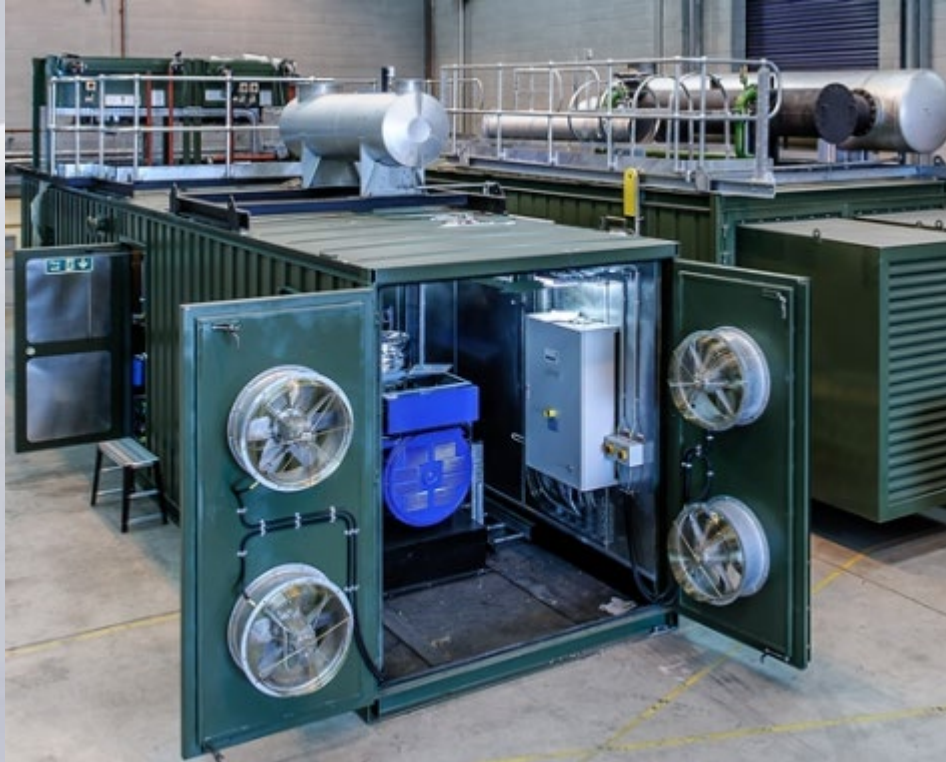
1. Purpose built container type
2. HV Gas fired Generator
3. Gas pipework c/w gas train and meter
4. Engine Coolant System
5. Room mounter Silencers
6. Exhaust mounted heat exchangers
7. CHP Control system
8. 1200 ltr Remote Clean Oil tank
9. 1200 ltr Remote Waste Oil tank

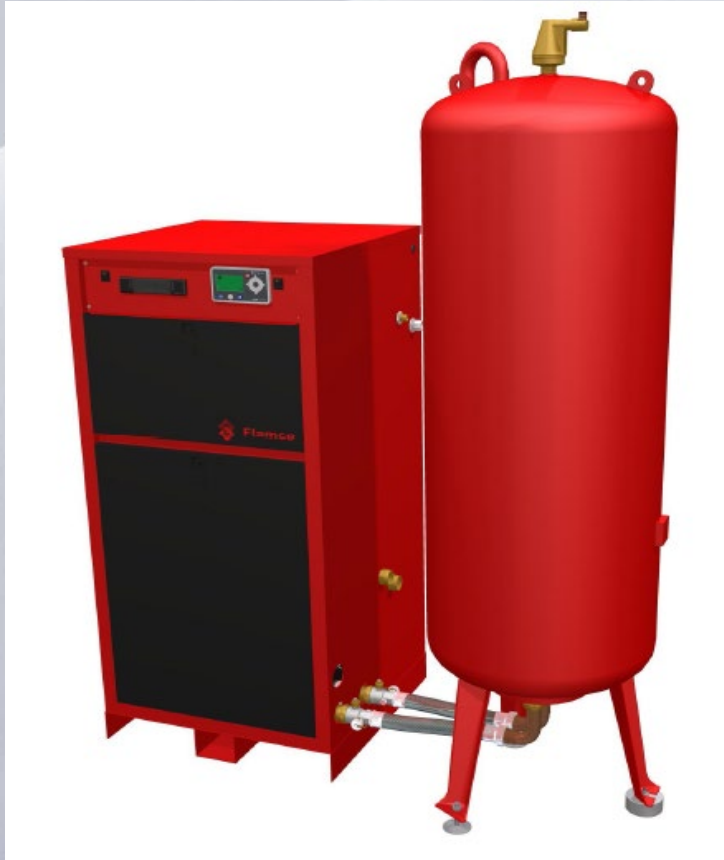
Wilomat Pressure-less Expansion

Suitable for larger systems instead of diaphragm units

Pressurisation and De-aeration

“Spill & Fill” As system expands it is filled from vessel
As it cools it contracts and spills into vessel

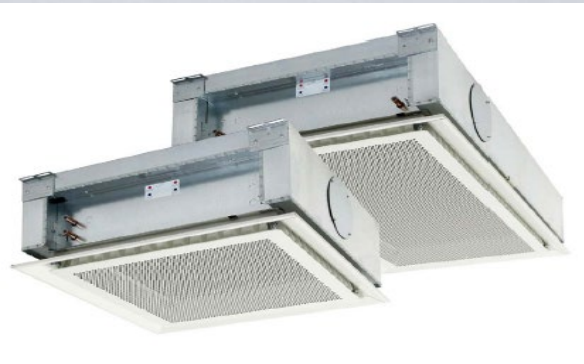
Chilled Beams (Swegon)

Ceiling mounted

High capacity heating and cooling

Fresh air supply

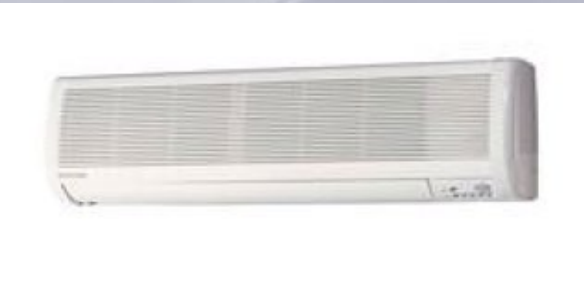
Fan Coil Units (Ability)

Wall mounted

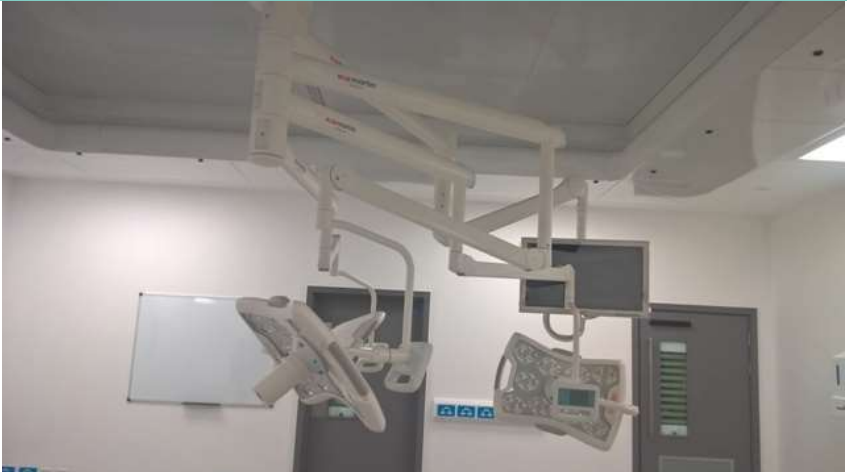
<p>Typical UCV canopy with equipment arm shown.</p>
2.

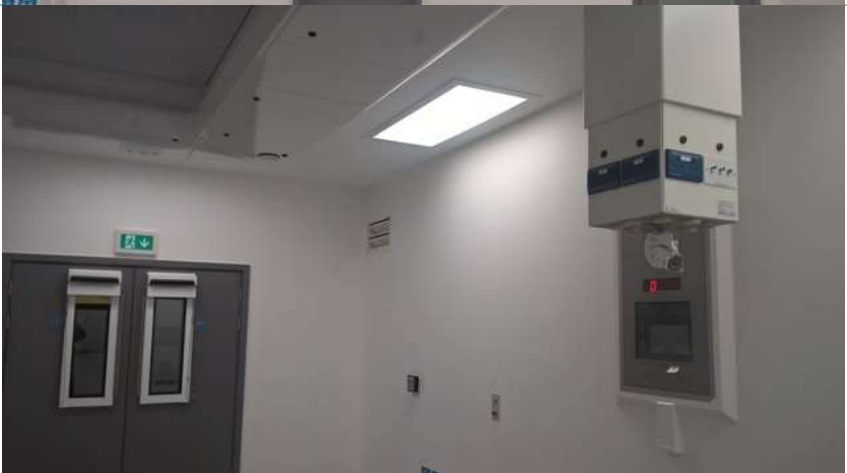
<p>Typical theatre showing UCV canopy, electrical / medical gas pendant and surgeon's panel.</p>
3.

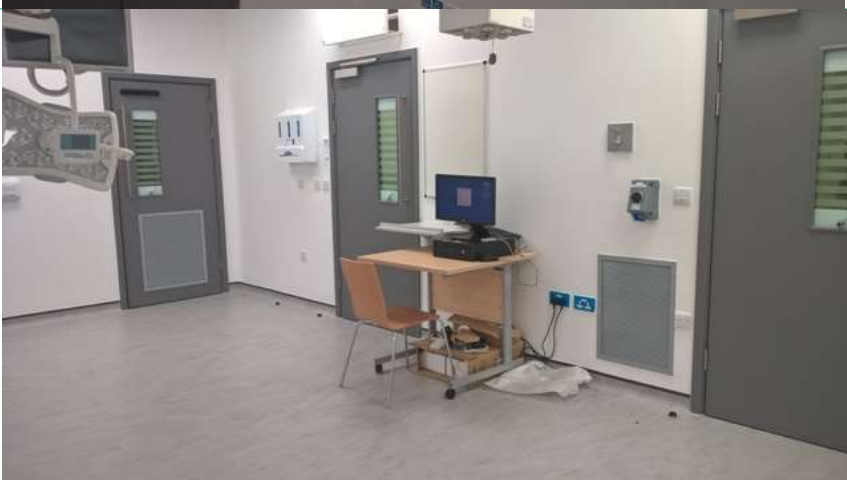
<p>Typical UCV theatre with exits to ancillary rooms, XRAY and laser sockets.</p>

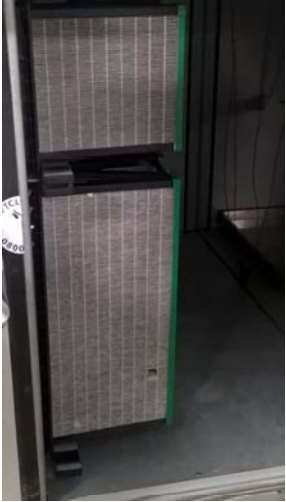
Typical main filter
9.

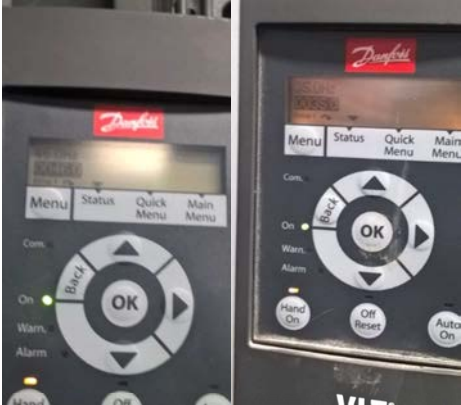
Fan variable speed drives. LHS image is supply. RHS image is extract.
