SCOTTISH HOSPITALS INQUIRY

**Bundle of documents for Oral hearings
commencing from 19 August 2024 in
relation to the Queen Elizabeth University
Hospital and the Royal Hospital for
Children, Glasgow**

**Bundle 24 - Documents referred to in the
Expert Report by Allan Bennett regarding
Cryptococcus, and Supporting
Documentation**

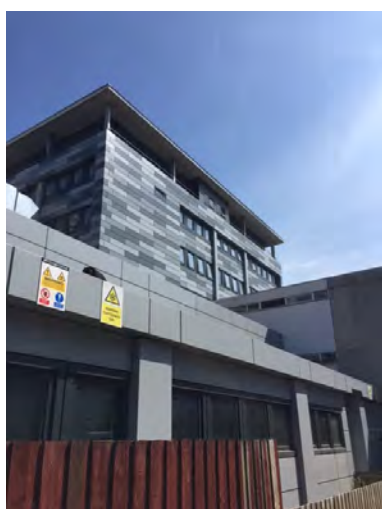
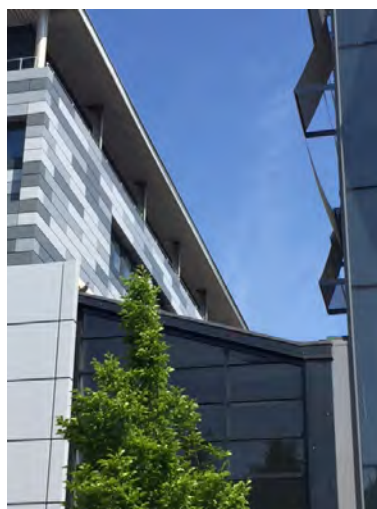
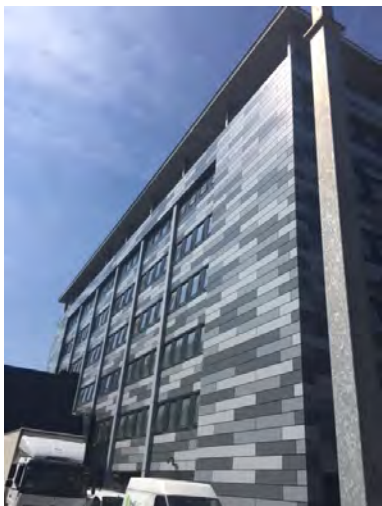
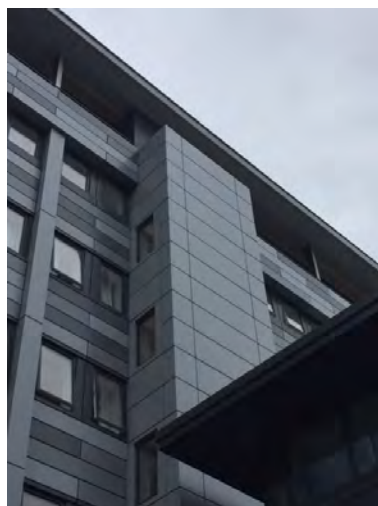
A similar amount of bird fouling, nesting materials and general associated detritus is present on both balconies with lesser house flies breeding within the fouling in significant numbers.

- GP Environmental recommend the deep clean and sanitisation of the entire contaminated balcony areas.
The bird fouling and associated detritus would be treated with a biocidal solution then uplifted and removed from site in secure receptacles for appropriate disposal.
- Following the deep clean and sanitisation works we also recommend the installation of non-obtrusive bird repellent netting along the frontage of the balcony to deny birds further access.

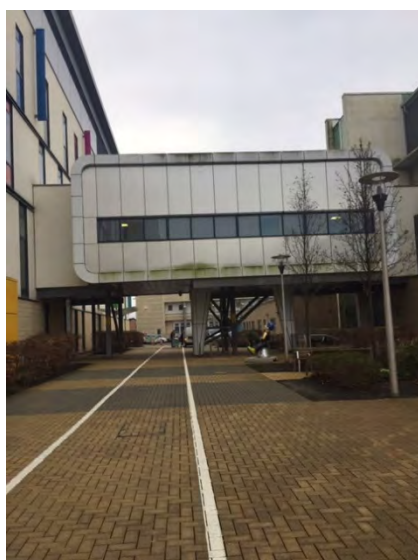
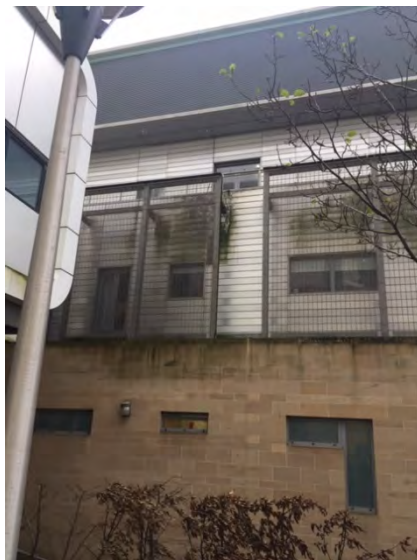
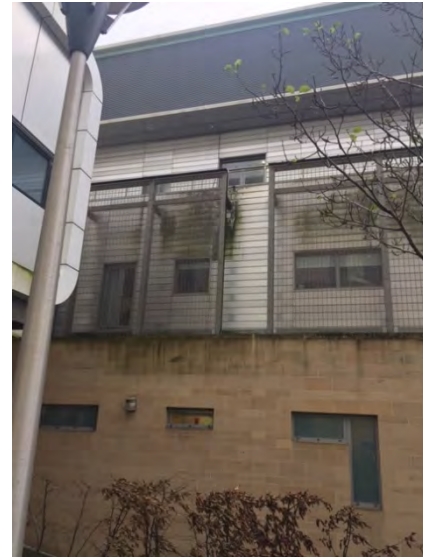
- To deep clean external surfaces of RHC/Maternity link bridge and wall cladding behind and around feature grills on Maternity Building.

- To apply bird repellent spike along the top leading roof edge of the link bridge (both elevations) to deny feral pigeons the ability to perch, roost and subsequently foul the windows and cladding.
- Access to deliver the works would be achieved using an appropriate hydraulic MEWP. Works being carried out at the weekend to minimise disruption and risk to staff, patients and the general public.
- Works would take place during daylight hours only to ensure clear sight of the areas to be cleared.

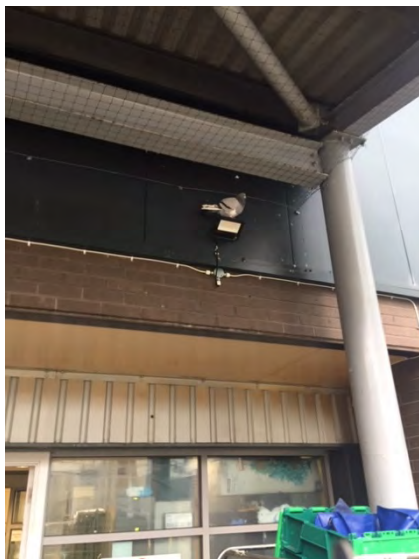
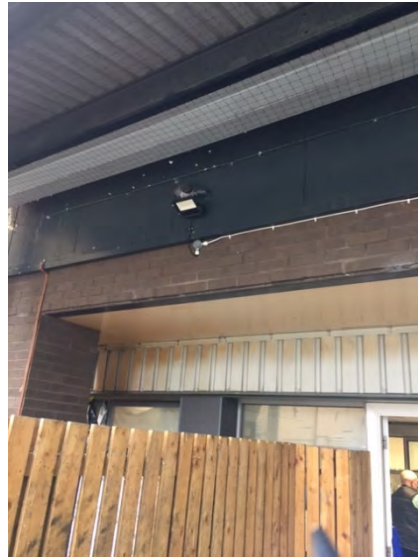
- To remove bird fouling from Loading Bay Spotlights and sanitise the lights and ground below.

- Apply bird repellent stainless steel spike to the upper surface of the spotlight to deny birds access to roost.
- Access to deliver these works would be achieved using a two (2) stage ladder.
- Works would take place during day shift hours (08:00-17:00) Monday-Friday

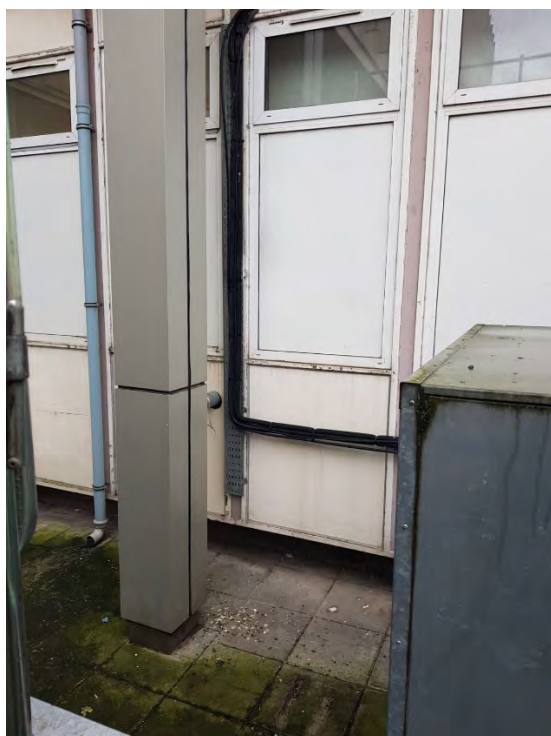
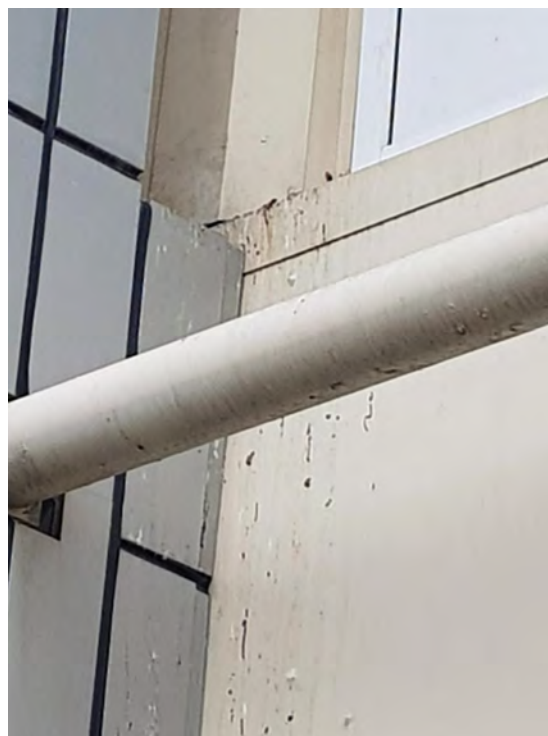
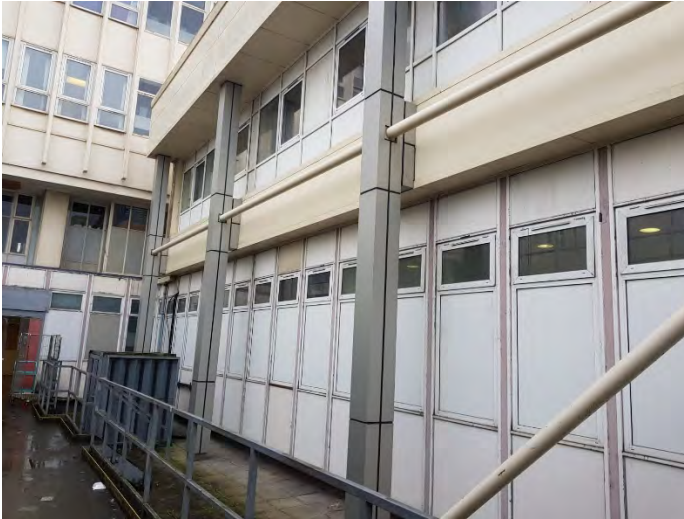
To deliver an Environmental Deep Clean and Sanitisation to the contaminated ledges and beams along the entire link walkway.

- Following the removal of feral pigeon contamination on the ledges, beams and grounds below, Stainless Steel Bird Repellent Spike will be applied to existing and potential roosting/nesting/perching sites.
- Access to deliver the cleaning and bird repellent works would be achieved using a Mi-tower and/or two stage ladders.
- The works would be carried out on day shift hours (8am-5pm) Mon-Fri with no disruption to the operational aspects of the Maternity Facility.

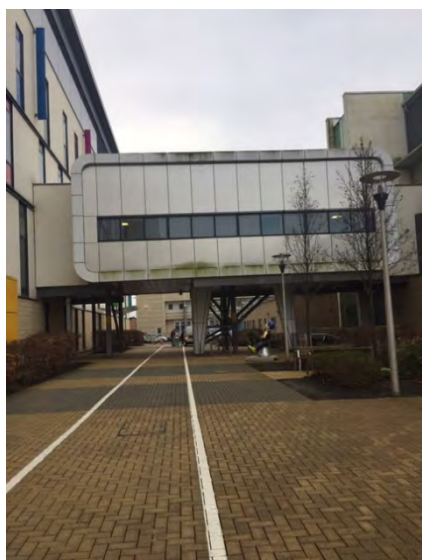
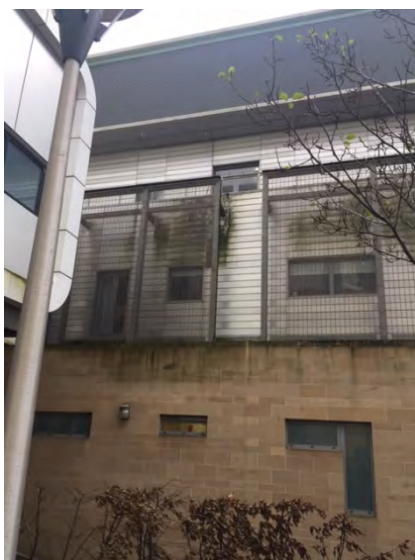
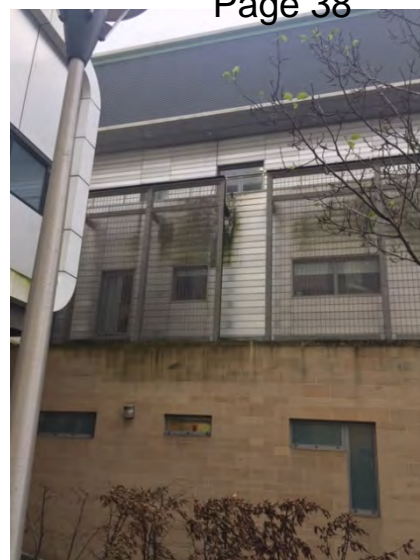
- To deep clean external surfaces of RHC/Maternity link bridge and wall cladding behind and around feature grills on Maternity Building.

- To apply bird repellent spike along the top leading roof edge of the link bridge (both elevations) to deny feral pigeons the ability to perch, roost and subsequently foul the windows and cladding.
- Access to deliver the works would be achieved using an appropriate hydraulic MEWP. Works being carried out at the weekend to minimise disruption and risk to staff, patients and the general public.
- Works would take place during daylight hours only to ensure clear sight of the areas to be cleared.

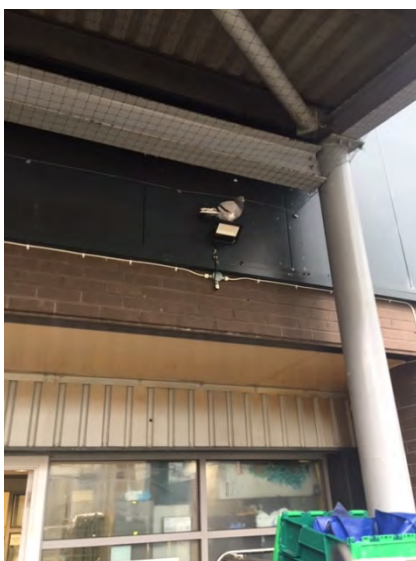
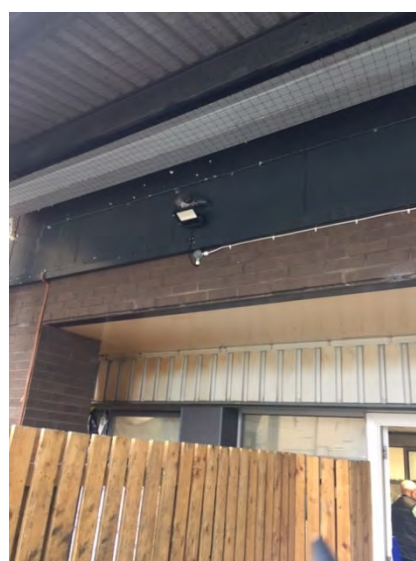
- To remove bird fouling from Loading Bay Spotlights and sanitise the lights and ground below.

- Apply bird repellent stainless steel spike to the upper surface of the spotlight to deny birds access to roost.
- Access to deliver these works would be achieved using a two (2) stage ladder.
- Works would take place during day shift hours (08:00-17:00) Monday-Friday

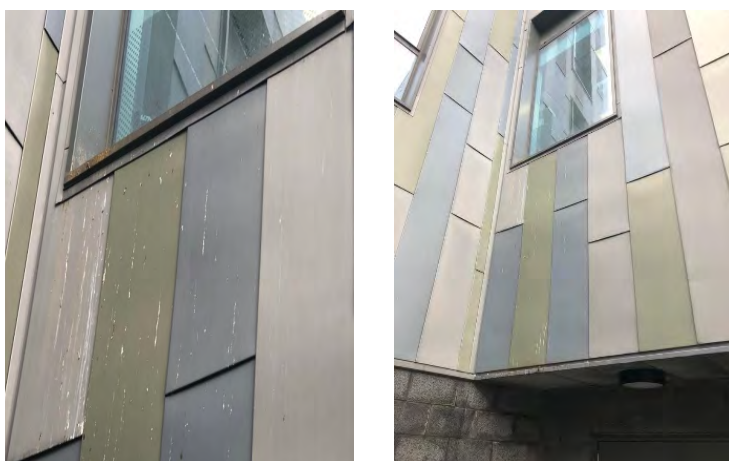
1. University of Glasgow Building Library

Pigeons are roosting on 8 ledges we recommend removal of all pigeon fouling, sanitisation of area with a biocide then installation of bird repellent spike to roosting site works would be carried out from specialised access equipment.

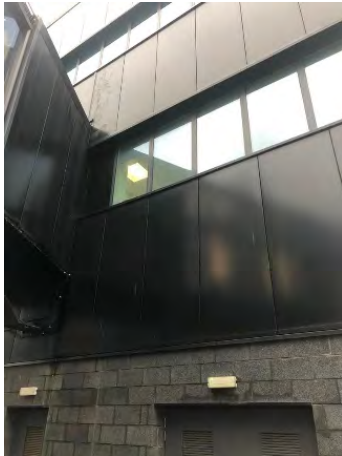
2. University of Glasgow Building

Pigeons are roosting on 2 exposed ledges we recommend removal of all pigeon fouling, sanitisation of area with a biocide then installation of bird repellent spike to roosting site works would be carried out from specialised access equipment.

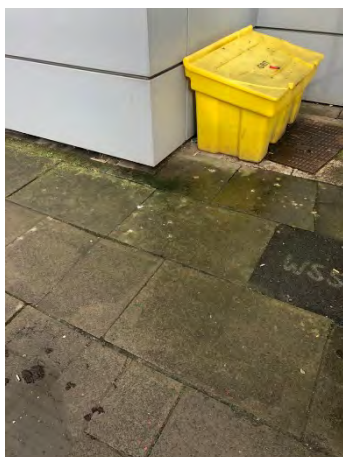
1. Neuro Block next to Link Bridge

Pigeons are roosting on ledge above we recommend removal of all pigeon fouling, sanitisation of area with a biocide then installation of bird repellent spike to roosting site.

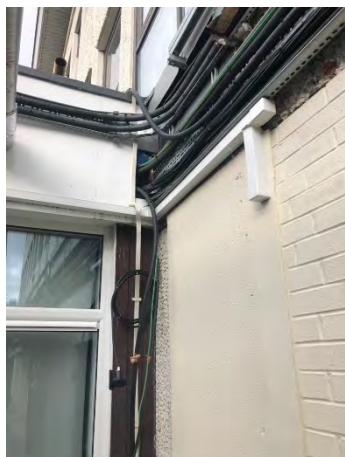
2. Neuro Block behind Back Car Park

Pigeons are roosting on cables and ledges above we recommend removal of all pigeon fouling, sanitisation of area with a biocide then installation of bird repellent mesh to roosting site.

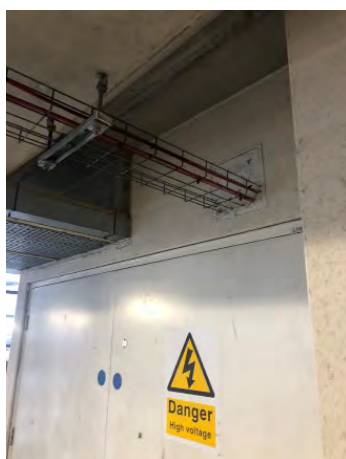
3. Multi Storey Car Park opposite CMB Building

Pigeons are roosting on cables and ledges above we recommend removal of all pigeon fouling, sanitisation of area with a biocide then installation of bird repellent spike to roosting site.

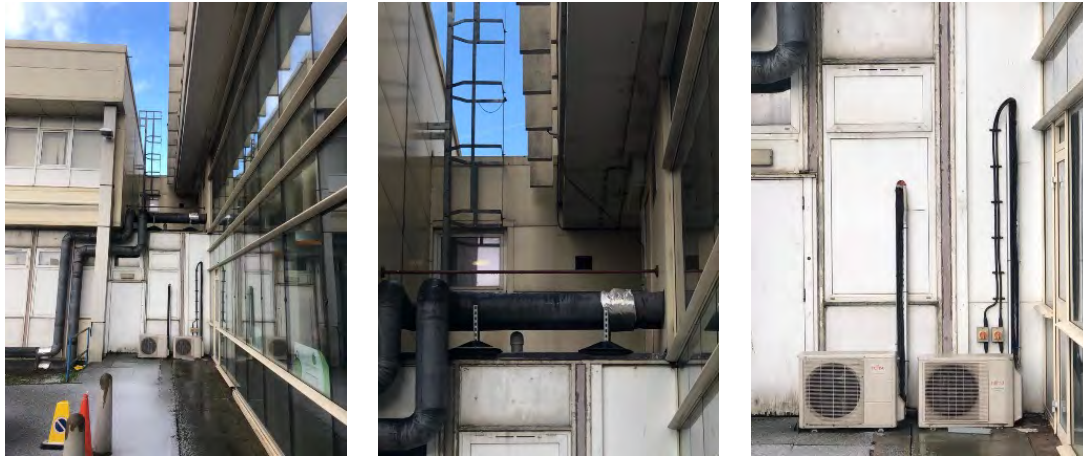
4. Side of Maternity Building Void Area

Pigeons are roosting and nesting within the void area we recommend removal of all pigeon fouling, sanitisation of area with a biocide then installation of bird repellent netting to prevent further ingress by pigeons.

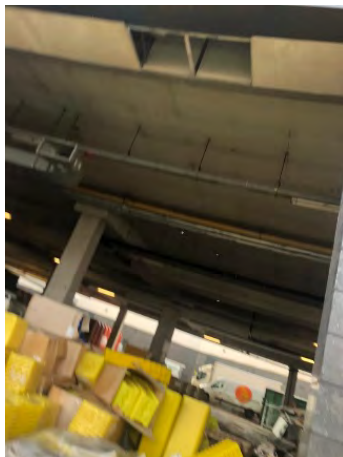
5. Loading Bay Next to Hazardous Waste

Pigeons are roosting in ceiling void due to missing tiles we recommend removal of all pigeons, pigeon fouling and nest materials followed by sanitisation of area with a biocide then installation of bird repellent mesh to prevent further ingress by pigeons into the void space.

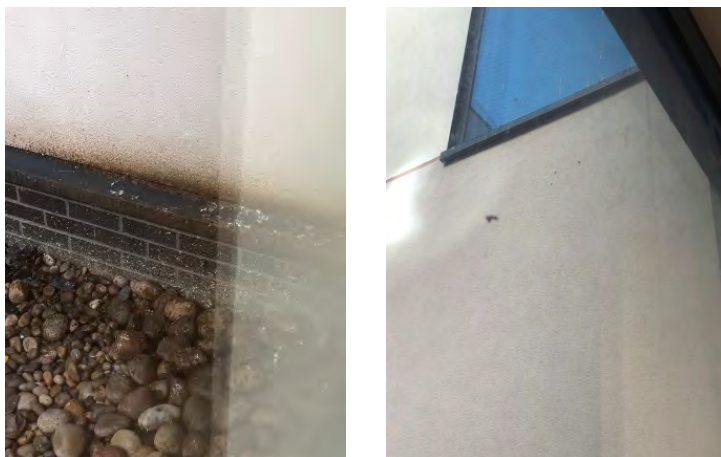
6. Small ED Light Well

Pigeons are roosting on ledge above we recommend removal of all pigeon fouling, sanitisation of area with a biocide then installation of bird repellent spike to roosting site

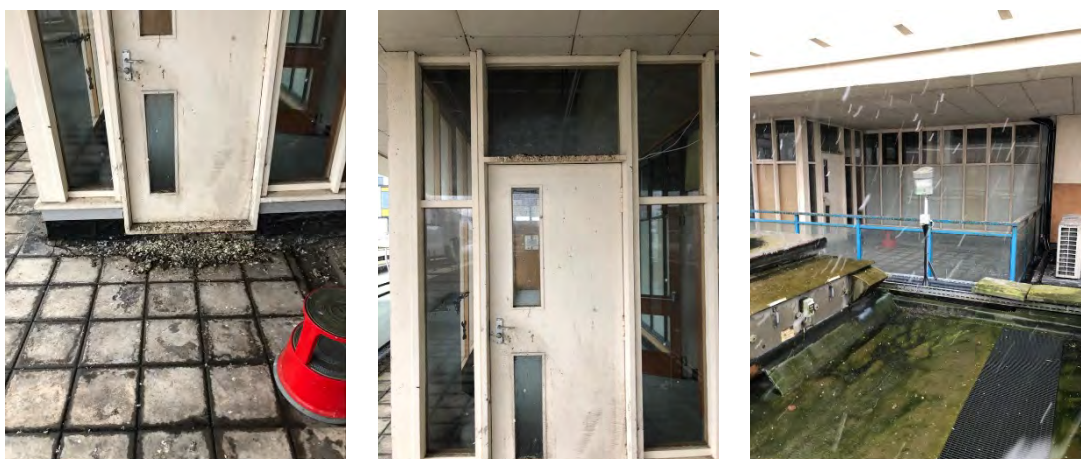
7. Rear of the Maternity Building

Pigeons are roosting above doorways and on all ledges we recommend removal of all pigeon fouling, sanitisation of area with a biocide then installation of bird repellent nets at the rear of Maternity Building.

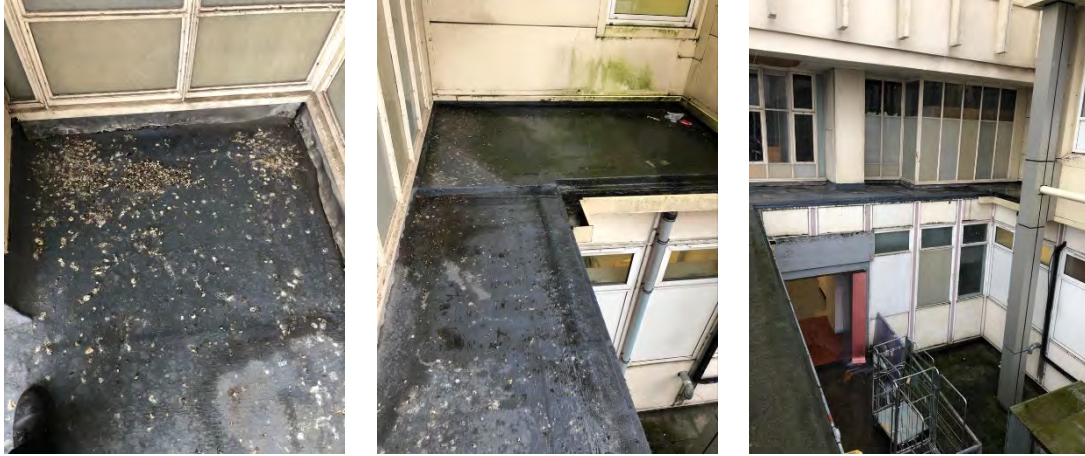
8. Back of Maternity Next to Loading Bay above Stop Curtains

Pigeons are roosting and nesting in void corner we recommend removal of all pigeon fouling, sanitisation of area with a biocide then installation of bird repellent nets to prevent further ingress from pigeons.

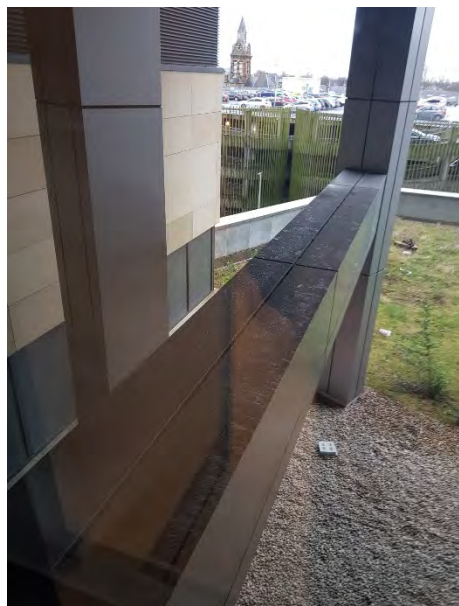
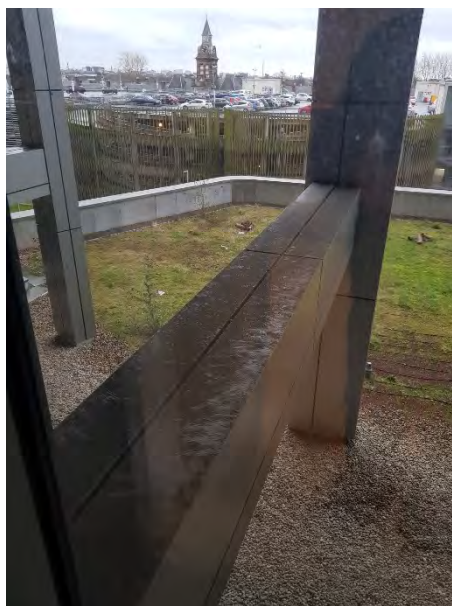
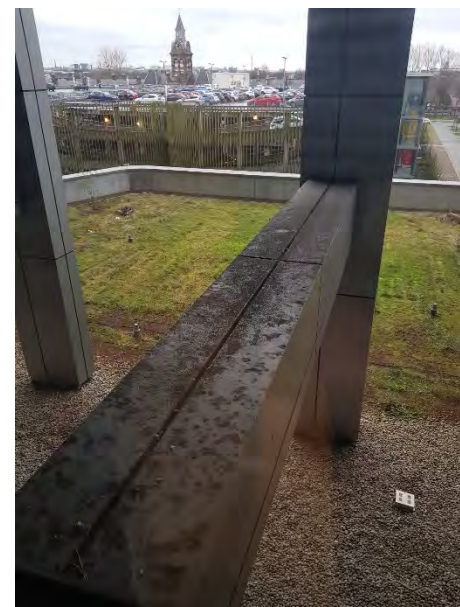
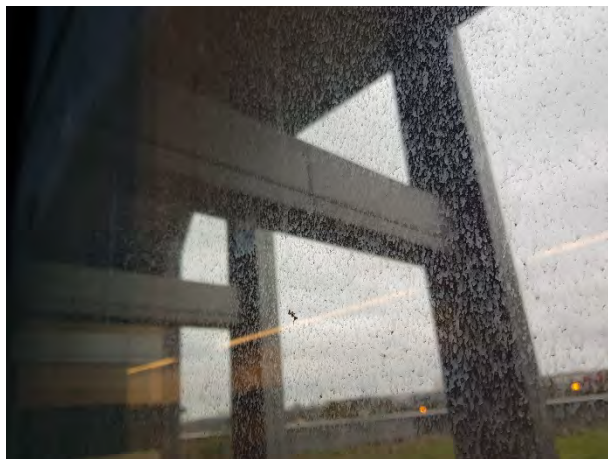
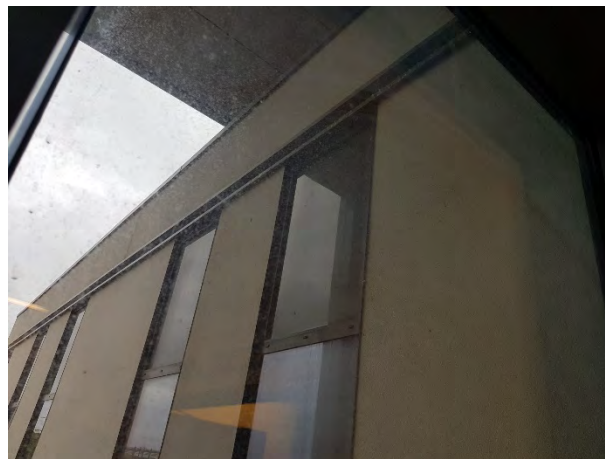
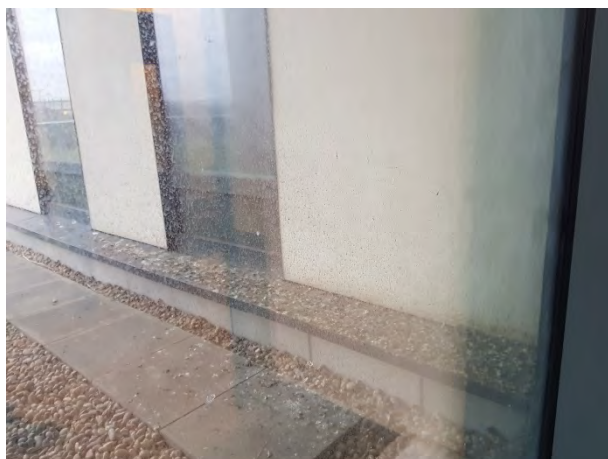
Further to our recent site inspection we noted feral pigeons roosting on the high ledges externally within the Level 3 of the Adult Hospital at QEUH.

Pigeons are roosting on the external high level ledges in this area. GP Environmental recommend a Specialised Environmental Deep Clean of all pigeon fouling followed by the sanitisation of area with a biocide then installation of bird repellent mesh to roosting site to prevent any further contamination.

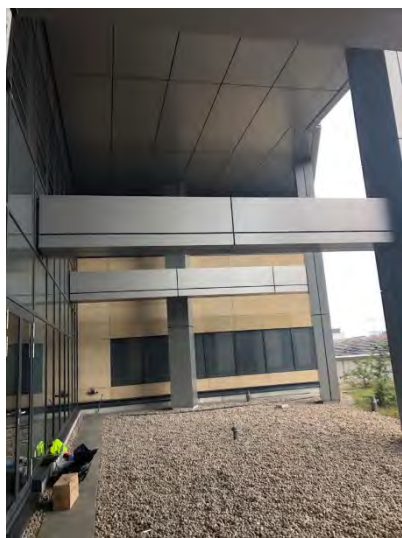
Further to our recent site inspection we noted feral pigeons roosting on the high ledges externally within the Level 2 of the Adult Hospital at QEUH.

Pigeons are roosting on the external level ledges in this area. GP Environmental recommend a Specialised Environmental Deep Clean of all pigeon fouling followed by the sanitisation of area with a biocide then installation of bird repellent mesh to roosting site to prevent any further contamination.

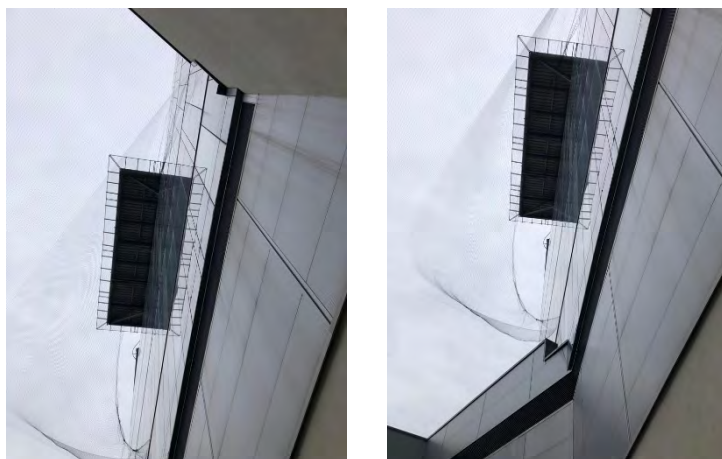
Further to our recent site inspection we noted damaged to the netting at Endoscopy.

Pigeons are gaining access due to damaged netting. GP Environmental recommend a Specialised Environmental Deep Clean of all pigeon fouling followed by the sanitisation of area with a biocide then a repair of bird repellent netting to prevent any further contamination.

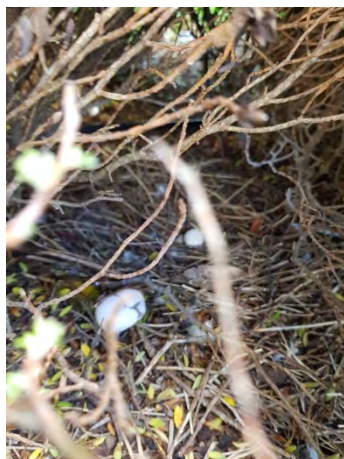
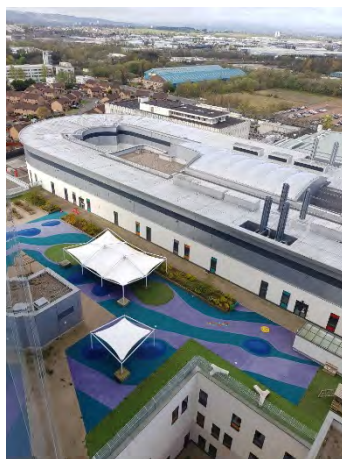
Further to our recent site inspection we noted feral pigeons roosting on the high ledges externally and nest in the shrubbery.

Pigeons are roosting on the external high-level ledges in this area. GP Environmental recommend a Specialised Environmental Deep Clean of all pigeon fouling followed by the sanitisation of area with a biocide then installation of bird repellent spike top ledge above windows to prevent any further contamination.

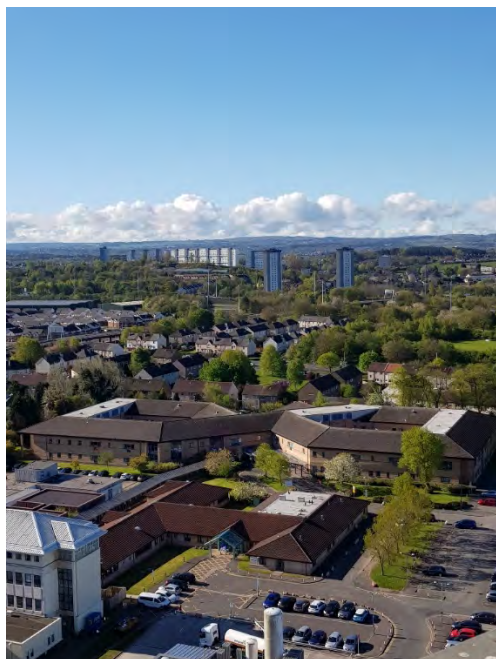
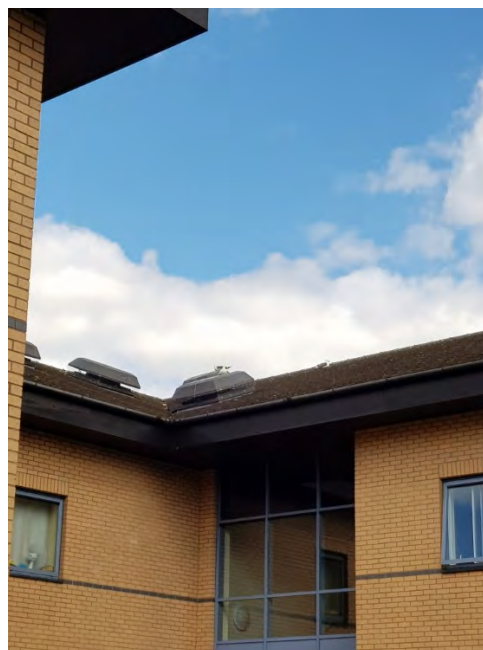
During a recent site visit by one of our surveyors, it was noted that gulls have started nesting on the Langlands Building.

During the breeding season the adult gulls become very protective of their eggs, nests and ultimately their young. This protective nature manifests itself as significant aggression from the adults to anyone near or in the vicinity of the buildings on which the nests are located eg staff, contractors, patients, etc.

GP Environmental recommend the mobilisation of a Gull Disruption/Net Removal Programme to minimise the nesting capability. This is the first year gulls have been noted as nesting on this building.

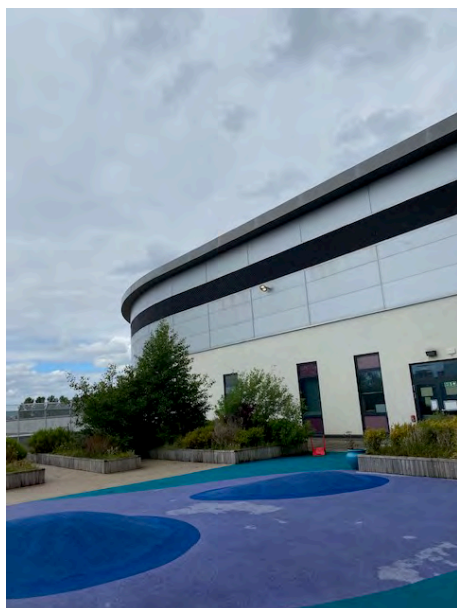
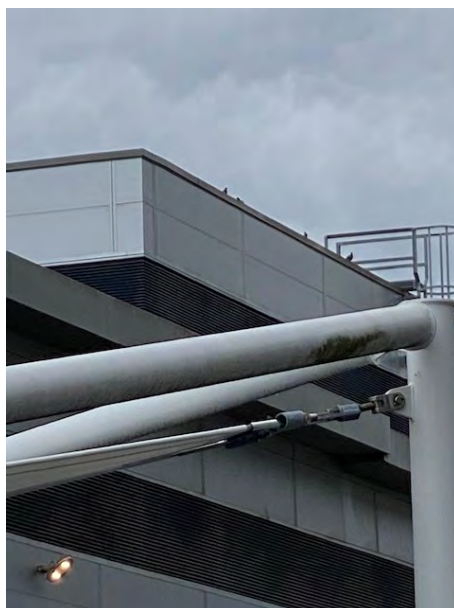
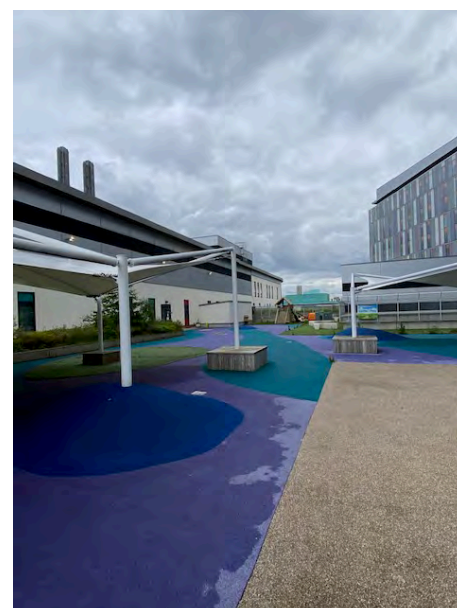
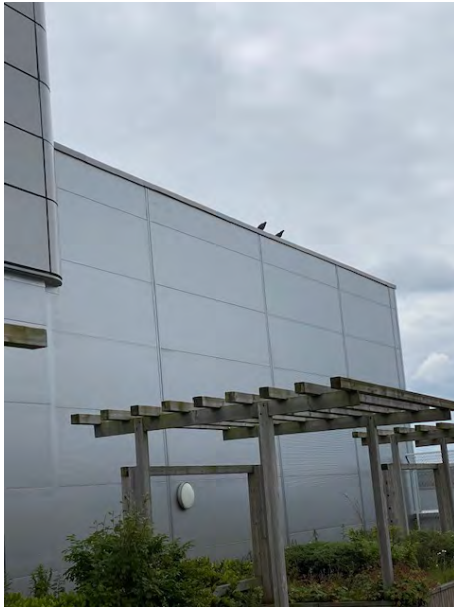
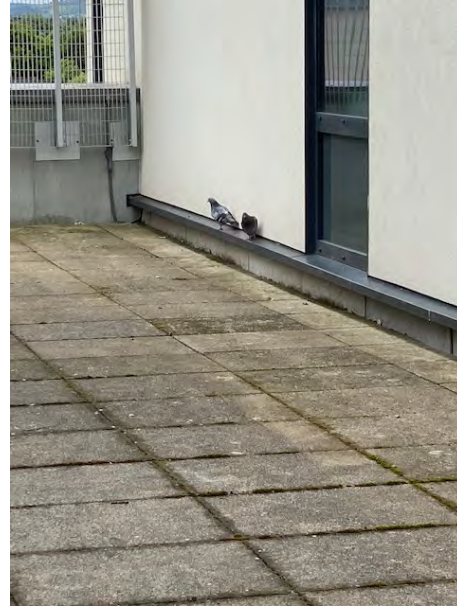
- To deny a significant number of feral pigeons the ability to roost, perch and subsequently infest the external play area on Level 3 of the Royal Hospital for Children. The birds are also contaminating the play area and surrounding paved walkway with droppings.

- To deep clean the play area surrounding leading edges (especially along Plant Room 40) and installation of pigeon repellent spike.
- Access to the leading edges would be achieved from the roof area behind each.
- Bird fouling/contamination build up in the play area would be removed to special waste disposal off site. The area cleaned would also be disinfected.
- All works would be delivered on day shift hours (08:00-17:00) Monday to Friday.

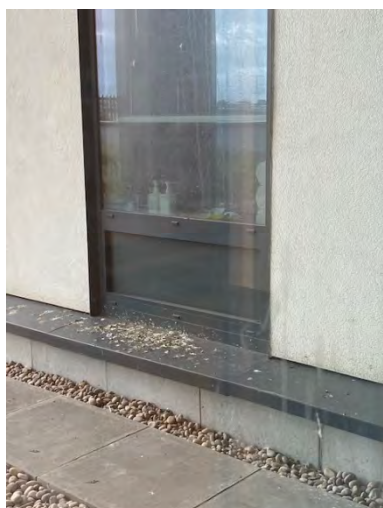
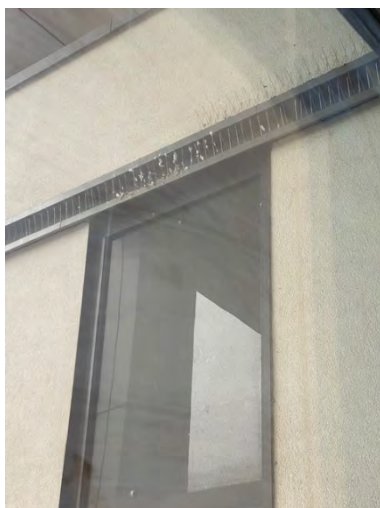
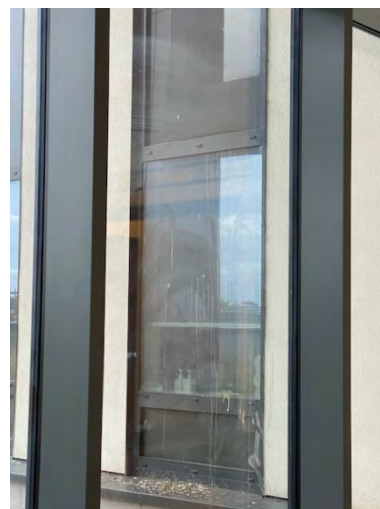
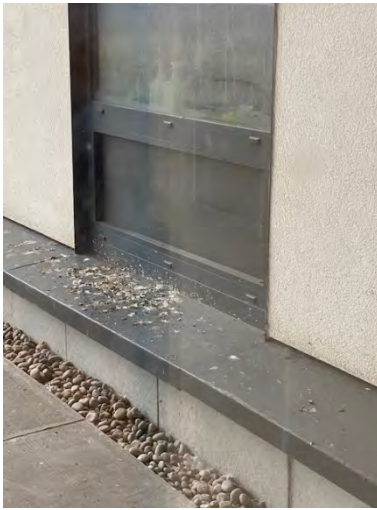
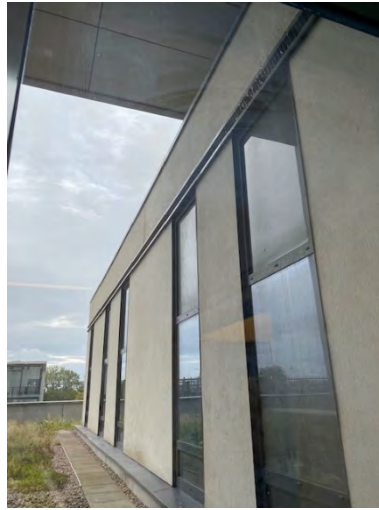
- To deny feral pigeons the ability to roost and significantly contaminate the ledges and roof area below.

- The bird fouling build up presents both an unsightly and Health and Safety Contamination Risk.
- To deny the ability of the feral pigeons to roost on the upper sheltered ledge bird repellent spike should be installed along the full length of the ledge. Prior to installation the ledge and the fouling build up below would be removed and the area sanitised.
- All works would be delivered during Day Shift hours (08:00-17:00) Monday to Friday.

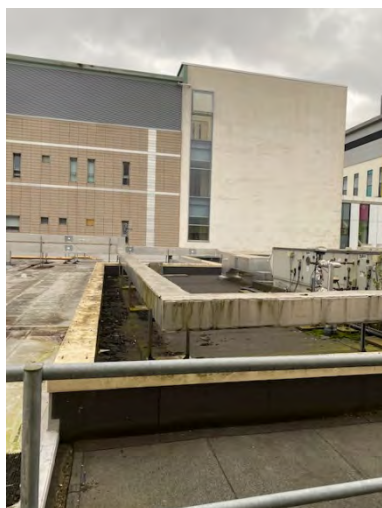
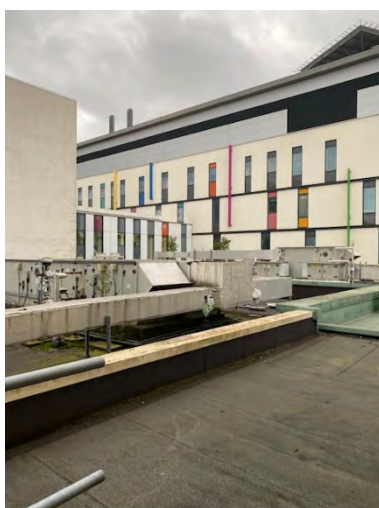
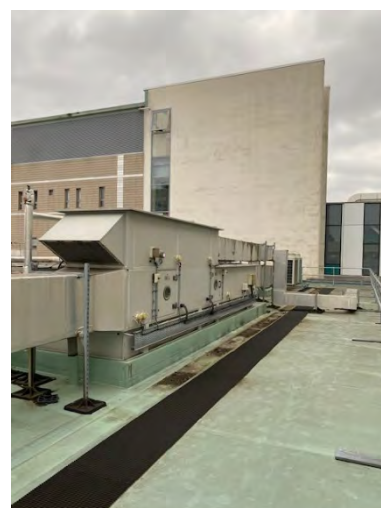
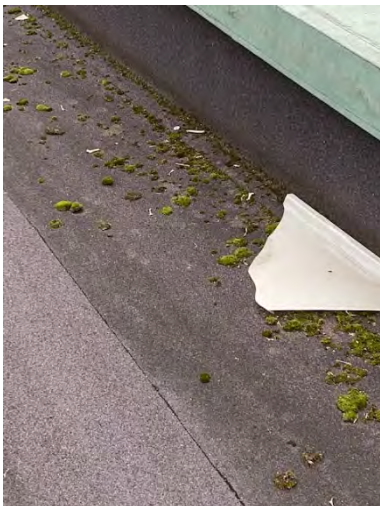
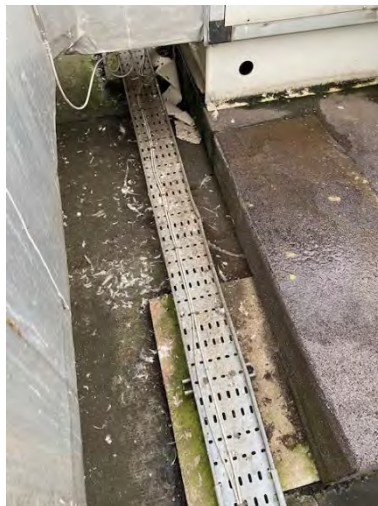
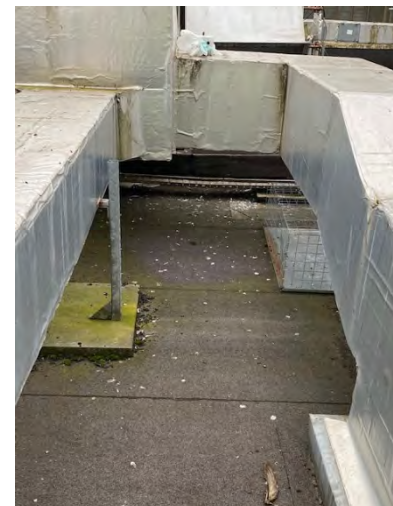
- To deliver an Environmental Clean to the external surfaces and roof area surrounding the Air Handling Units above the Ultrasound Department. Encompassing duct support stanchion bases, drainage gullies, ducting motor chamber doors, air intake grills, etc.

- The feral pigeon detritus/fouling accumulation presents a material Health and Safety Risk to personnel working in or around this air handling equipment. As such we would recommend these Environmental Cleaning Works be actioned as soon as possible.
- The works would be delivered on day shift hours (08:00-17:00) Monday to Friday.
- All accumulated contaminated waste would be sanitised, secured and removed from site for special waste disposal.

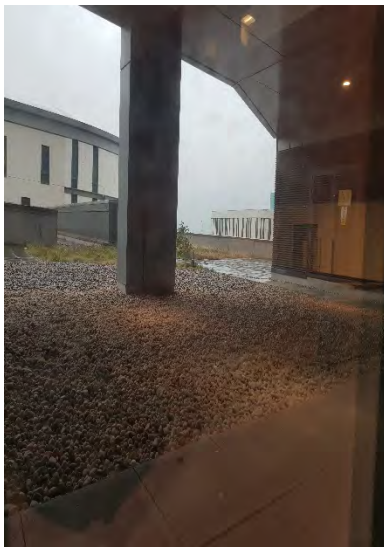
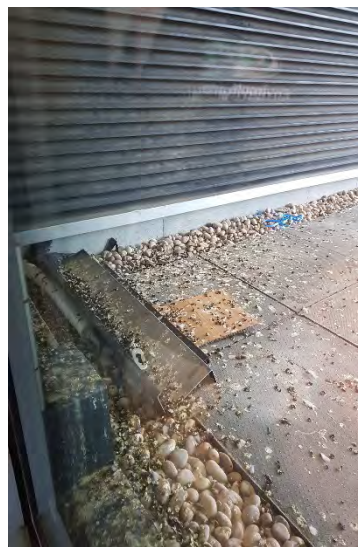
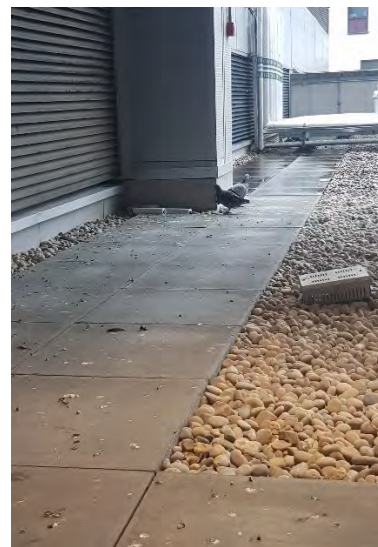
Further to our recent site inspection we noted feral pigeons roosting and fouling in this area.

Pigeons are roosting and fouling in this area. GP Environmental recommend a Specialised Environmental Deep Clean of all pigeon fouling followed by the sanitisation of area with a biocide then installation of bird repellent netting to be installed in the alcoves between the pillars to prevent any further ingress or contamination.

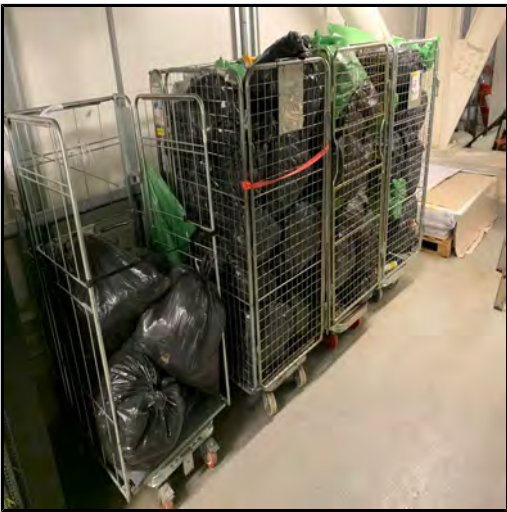
Completed Works, Level 12, Waste Removed

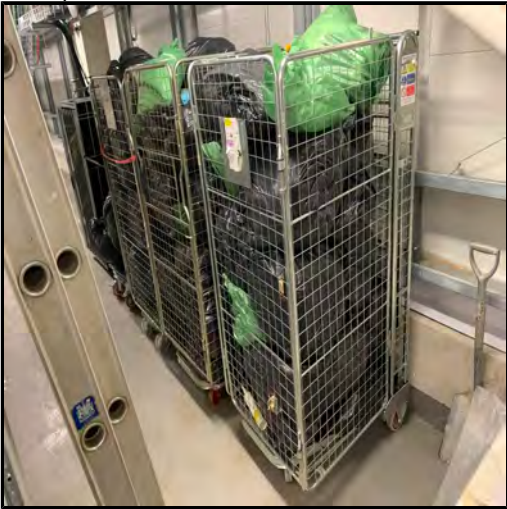
Completed Works, Level 12, Waste Removed

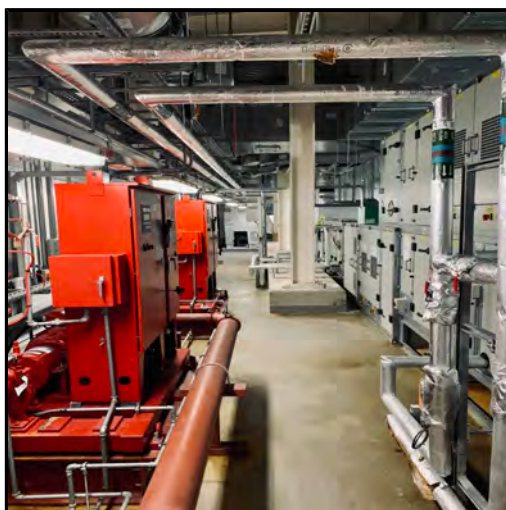
Completed Works, Plantroom 121

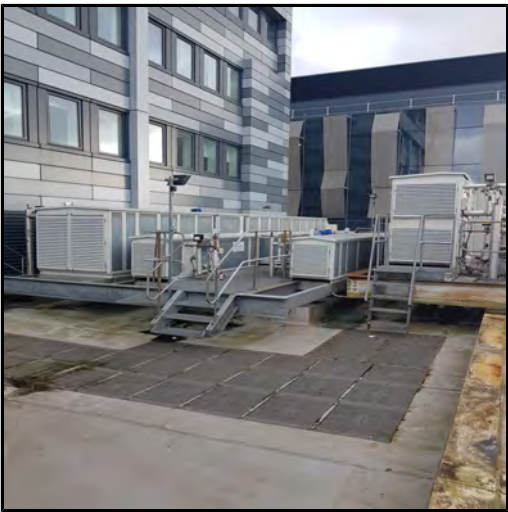
Net 1

Pigeons found nesting underneath the vents on both sides on level 2. Trapping and proofing is needed. A 15x30 net and 20x20 net will be needed to prevent further issues.

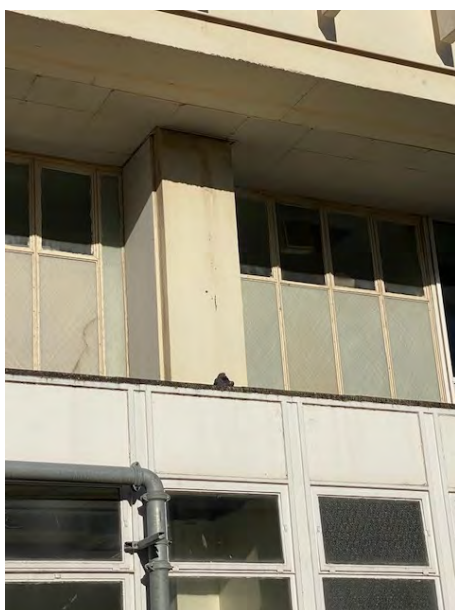
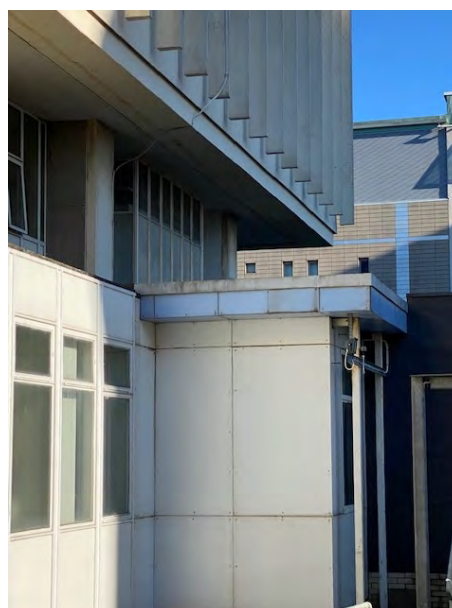
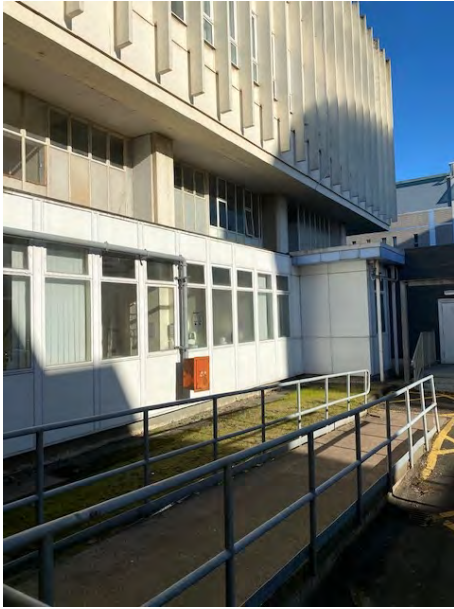
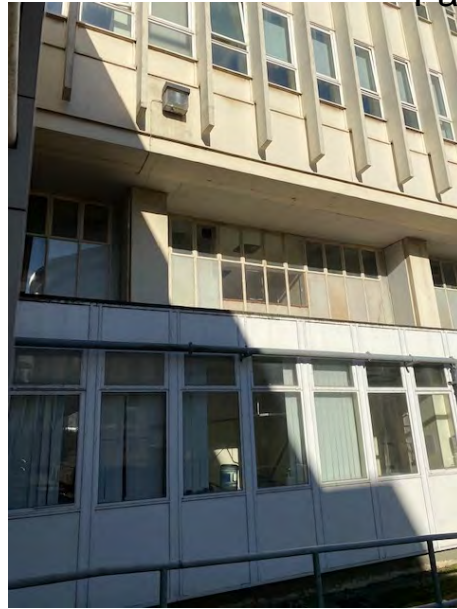
- Feral pigeons are congregating, in significant numbers, on the flat roof area below the second floor overhang beside the East Entrance to the Maternity Building. They are also using the roof leading edge of the building above the courtyard to roost before landing on the area below.

See photographs of the issues:-

- To remove all feral pigeon fouling and associated detritus from the full length of the flat roof and sanitise the area. Following the sanitisation we would install a feral pigeon repellent net system to deny the birds access to the area.
- To supply and install feral pigeon repellent spike to the leading edge of the building above the Courtyard to prevent advantage point roosting.
- All works would be delivered on dayshifts 08:00-17:00 Monday to Friday. No disruption to the daily operation of the Maternity Unit will occur.

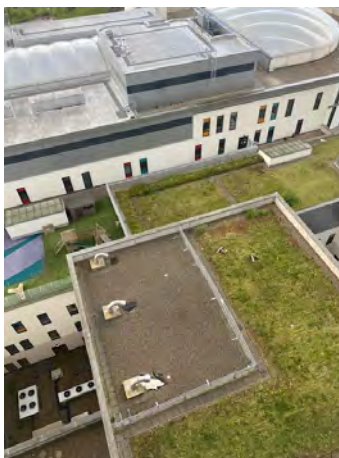
- To install feral pigeon exclusion net above the flat roof area being used by the birds as a safe harbourage

See photograph of area:-

- Entire flat roof area of pebble drainage and wild flower meadow would be cleaned, sanitised and cleared of all bird fouling/nests and associated detritus.
- Immediately following the Environmental Clean and Feral Pigeon Exclusion Net would be installed. This net would be set in position using galvanised stanchions (2.5m in height) stabilized to the corners and edge of the roof by appropriate and approved weights.
- The net would be constructed into a box structure giving personnel easy access to the roof for maintenance etc. The roof would be accessed through the net by installation of a Zip Door.
- The above noted will be delivered on day shift hours (08:00-17:00) Monday to Friday.

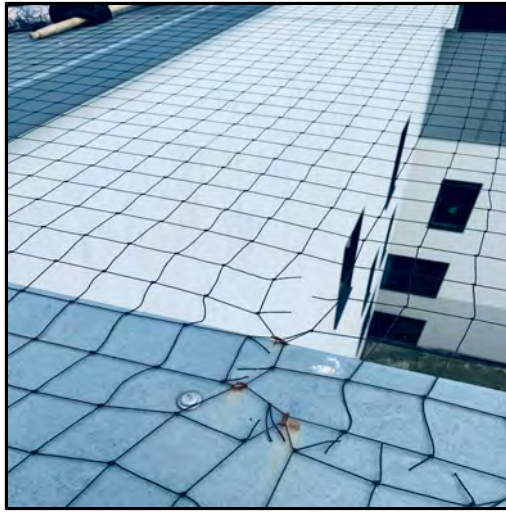
QEUH, L4, Green Roof, Potential Net Repairs, Left Net, 13 07 21

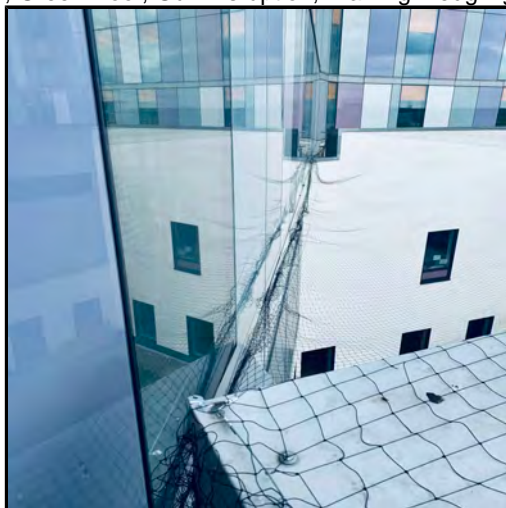
QEUH, L4, Green Roof, Potential Net Repairs, Right Net, 13 07 21

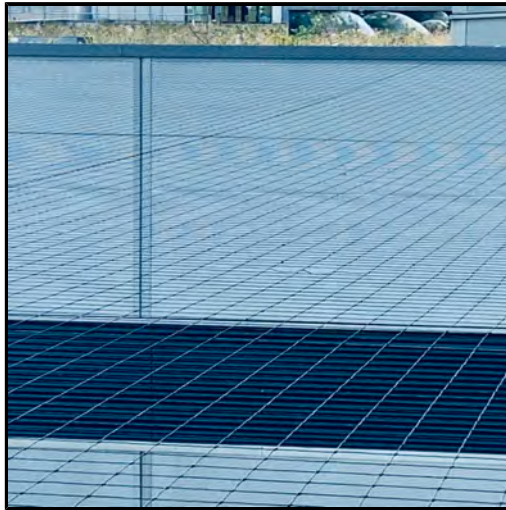
QEUH, L4, Green Roof, Potential Net Repairs, Left Net, 13 07 21

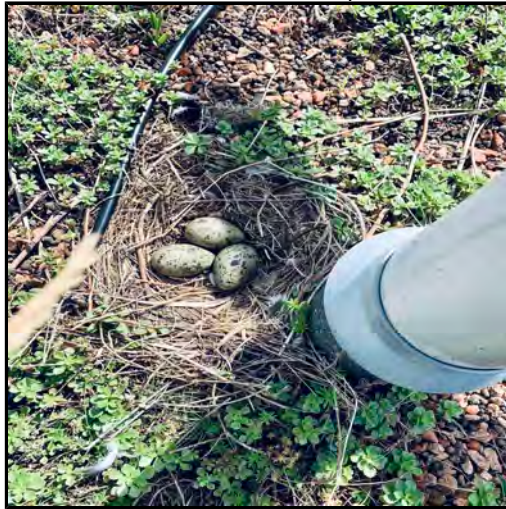
QEUH, L4, Green Roof, Gull Disruption, Nest, 13 07 21

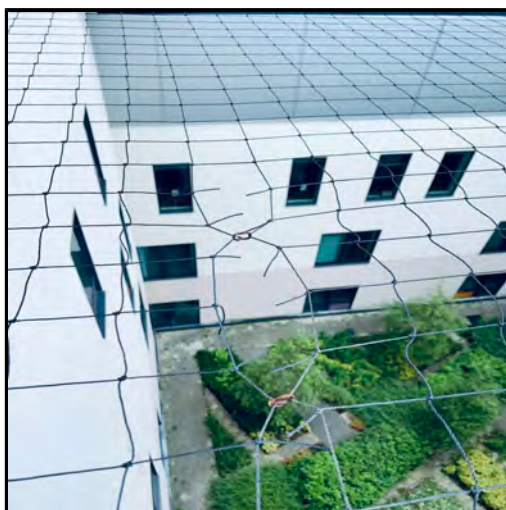
QEUH, L4, Green Roof, Potential Net Repairs, Left Net, 13 07 21

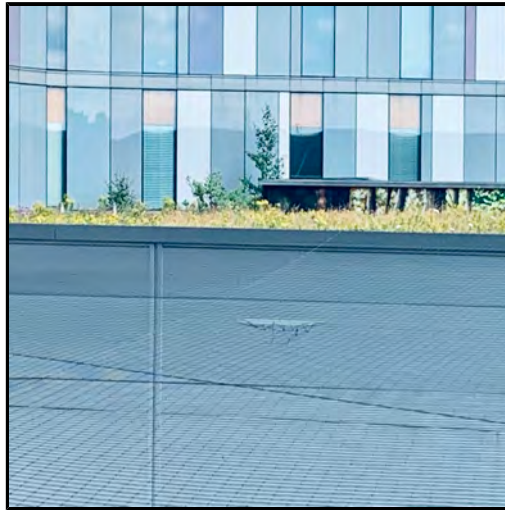
QEUH, L4, Green Roof, Potential Net Repairs, Right Net, 13 07 21

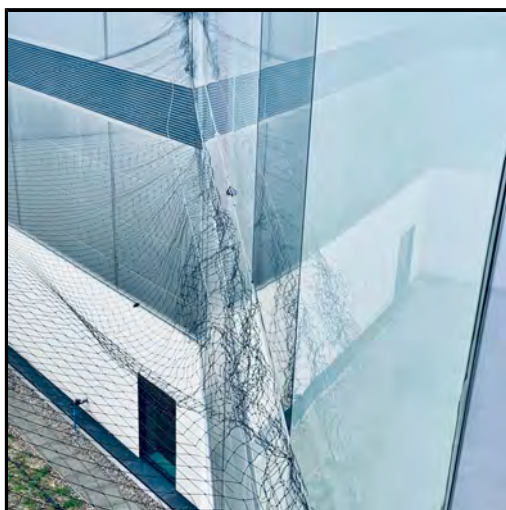
QEUH, L4, Green Roof, Potential Net Repairs, Left Net, 13 07 21
