SCOTTISH HOSPITALS INQUIRY

**Bundle of documents for Oral hearings
commencing from 19 August 2024 in
relation to the Queen Elizabeth University
Hospital and the Royal Hospital for
Children, Glasgow**

**Bundle 24 - Documents referred to in the
Expert Report by Allan Bennett regarding
Cryptococcus, and Supporting
Documentation**

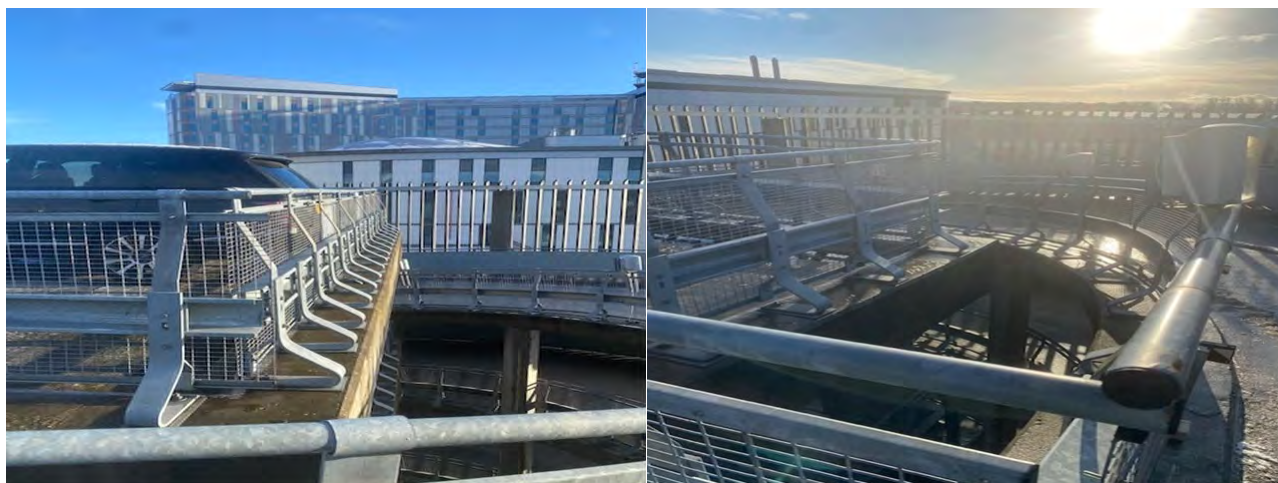
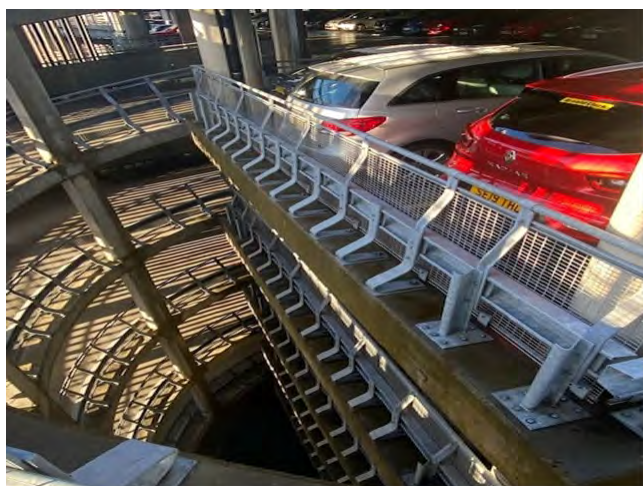
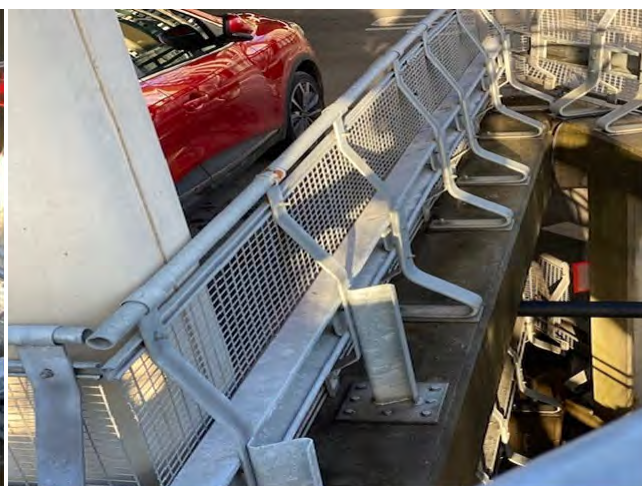
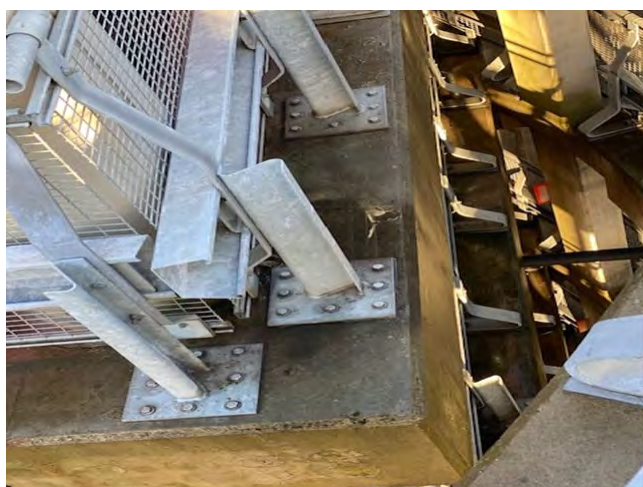
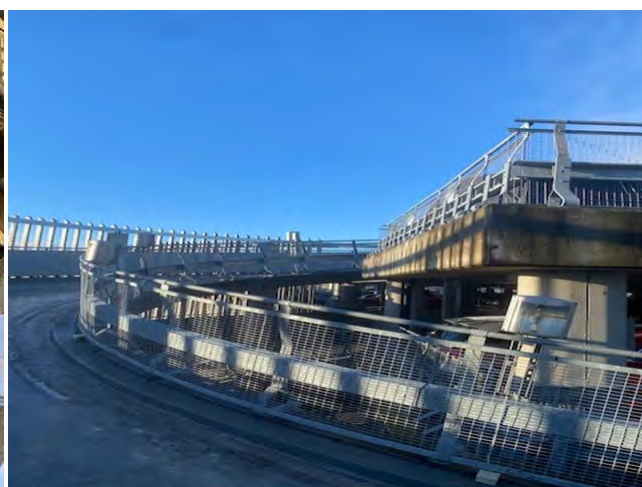
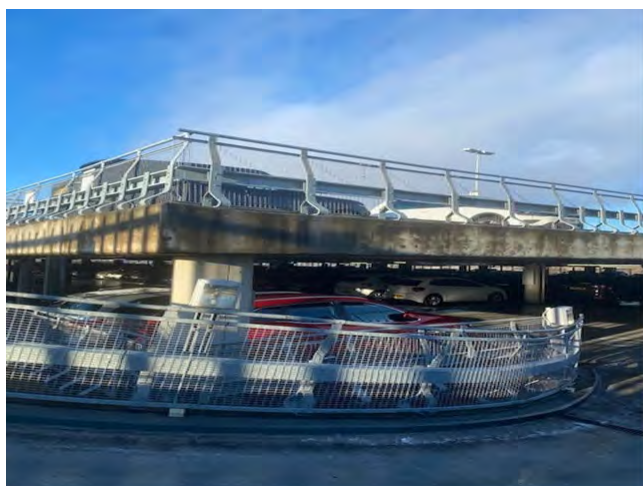
See photographs of the issues associated with each car park below:-

Ref:- Supply and Installation of Heavy Duty (19mm gauge) Bird Exclusion and Safety Netting to Vehicle Entrance and Exit Spiral Roadway Side and Top Elevations – MSCP P1 + P2, QEUH, 1345 Govan Road, Glasgow, G51 4TF
